## Corrosion of Aluminum Die-castings Jointed with Rubber

In automobiles, a suspension bush, a set of aluminum parts connected to each other via rubber, is mounted into the suspension members to link the body to the wheels, and realizes hard and soft mounts contributing both to the stabilization during high speed driving and to absorbing the shock from the road. However, decohesion of the aluminum part from the rubber occurs occasionally, arising from the interface corrosion of aluminum, which deteriorates the performance of the vehicle directly. In this study, effects of alloy composition and processing route on this kind of corrosion have been investigated. Low durability caused by decohesion of the joint was found in pressure-die-cast ADC12 and ADC3 alloys. In general, small amount of impurity Fe and alloying Cu tended to cause the low durability. In pressure-die-cast ADC12, large fraction of eutectic area adjacent to the surface was deduced to be the cause of the low durability.

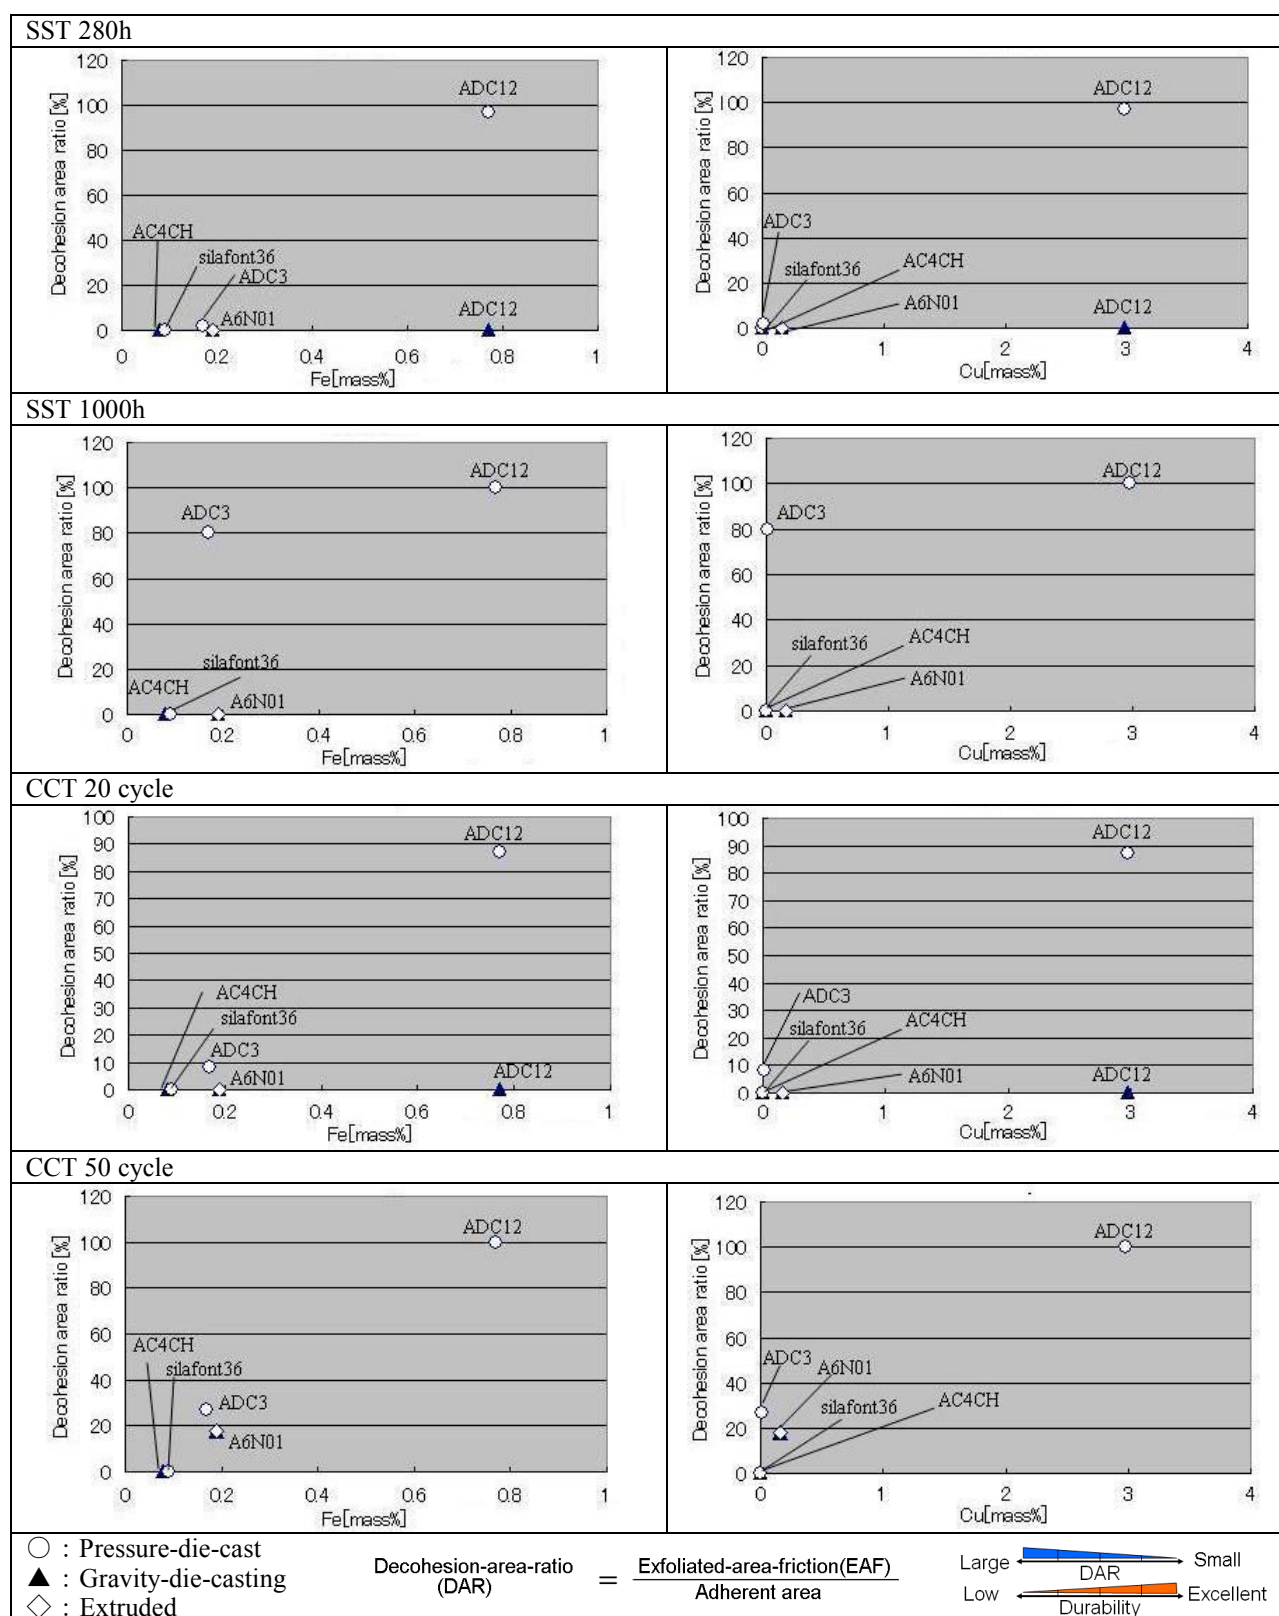
The results obtained in the durability tests (SST and CCT) are shown in Fig. 3 as a function of Fe and Cu contents. High durability (with no decohesion) can be seen in A6N01, AC4CH, ADC3 and Silafont36 that contain about 0.2% Fe and Cu in SST at 280h, while ADC12/PDC shows serious decohesion. The ADC3 results in 80% decohesion in SST at 1000h. In CCT under 50 cycles, A6N01 shows no decohesion. The AC4CH and silafont36 remained sound throughout the whole durability test. In general, the durability is prone to decrease with increasing Fe and Cu content. However, it is to be noted that the occurrence of decohesion changes markedly with the processing route in ADC12 in spite of the same alloy composition.

Fig.3 Result of corrosion tests.

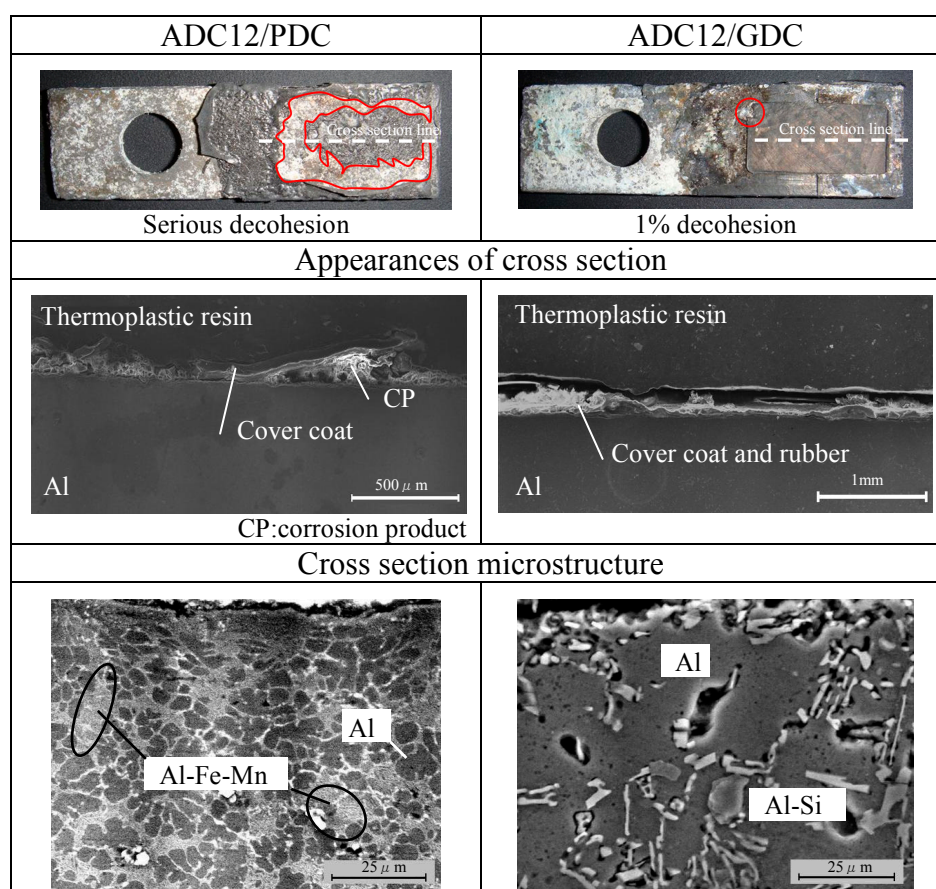
Appearances of ADC12/PDC and GDC test pieces after SST by 540 cycles is shown in Fig. 4 with SEM images. In ADC12/GDC, corrosion is found to take place in primer and cover coat, while in ADC12/PDC, serious corrosion occurs, resulting in corrosion products. The area fraction of eutectic area in ADC12/PDC is larger than in ADC12/GDC according to the microstructure on the cross section. This is thought to be the cause for the result that ADC12/PDC was more prone to be

corroded than ADC12/GDC. In addition, in ADC12/PDC, the durability was found to be improved when 10-1100 $\mu$ m of the surface layer was removed by etching in a strong acid or by mechanical milling

Fig. 4 Macroscopic appearance and SEM image of ADC12/PDC and ADC12/GDC test pieces after SST by 540 cycles that have been originally jointed with rubber. **CP: corrosion product.**
