## FORMING OF FOOD CANS - FORMING DEFECTS RELATED TO COMPLEX STRAIN PATHS

### Abstract

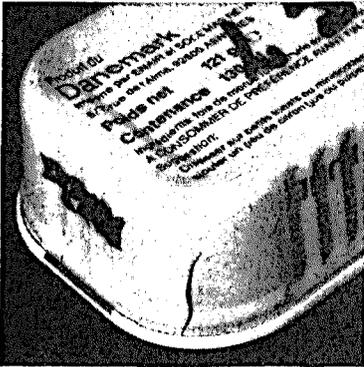
The first is a fracture or a near-fracture in the wall at the corner (Fig. 1) after the second drawing operation where the corner was stretched to be wrinkle-free. It was surprising that this happened for the apparent most formable material.

Fig. 1. Optical macro image of a fracture at the corner of a two step drawn club can.

The surface areas around the defect have been characterized and examples of a severe fracture and a small depression are shown in Fig. 3 together with the corresponding cross sections of the two defects. As seen, the defect starts as a localized instability running in the drawing direction meaning that it is a plane strain condition with components in thickness and transverse drawing direction. At later stage, the fracture runs in a S-shape. The initiation is typical for plastic instability which develops when the work hardening do not compensate for geometrical softening. The instability as seen in Fig 3d is asymmetrical compared to normal tensile testing due to the curved surface. The governing property in such cases is the reduced work hardening

capacity i.e. matrix properties. This is underlined by the fact that the instability always starts on the same position and no other factor such as presence of large particles, could be found.

Consequently, it is concluded that a lower work hardening capacity of the AA5050 material is causing the problems. But as seen from table 1, the work hardening as measured by uniform elongation (equal to the n-value in the Holoman expression  $\sigma = K\epsilon^n$ ) and also ductility measured by total elongation is clearly better for the AA5050.

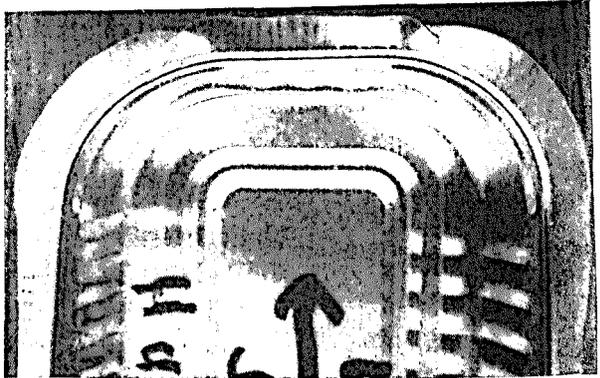
The other was a fracture in the flange between the short end and the corner (Fig. 2). This happened only with AA5050 material and only when the rolling direction was along the length of the can.

Fig. 2. Optical macro image of a fracture in the flange between the short edge and the corners after the second drawing operation.

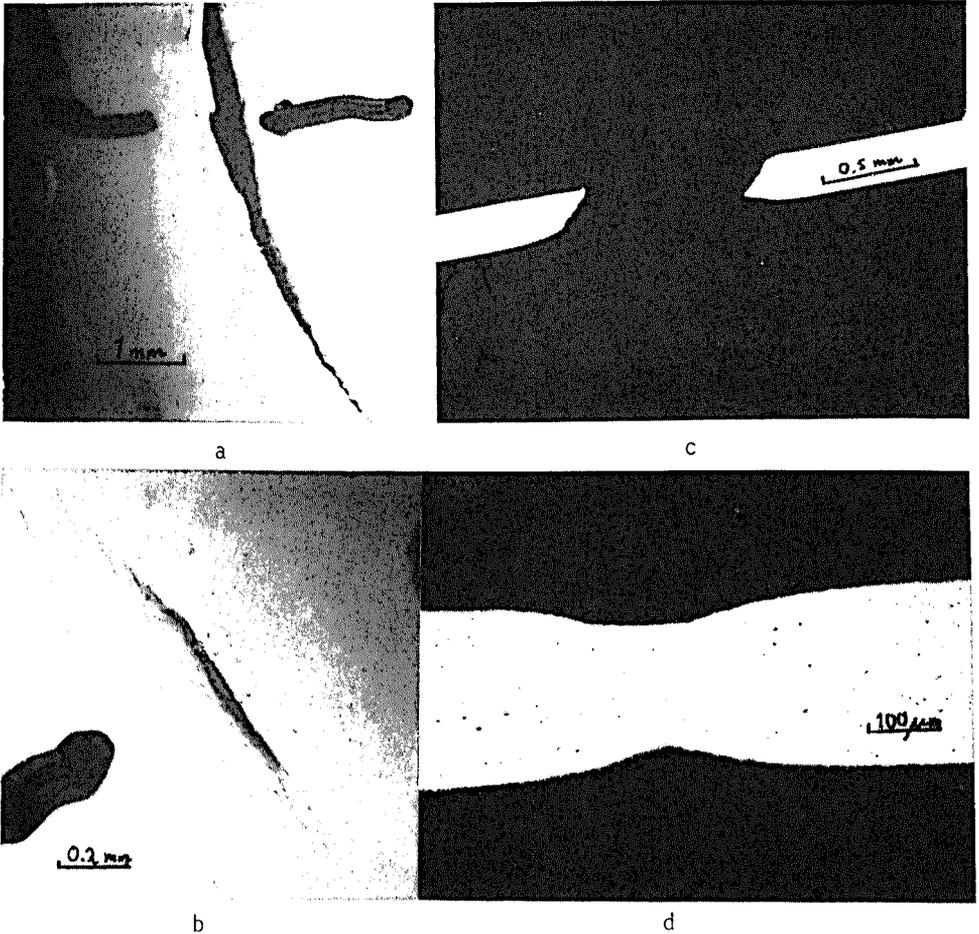
Fig.3. Optical macro image of the corner area showing a) a large defect (upper left) and b) a small defect (lower left) with the corresponding crosssection c) and d) between the black marks (right)

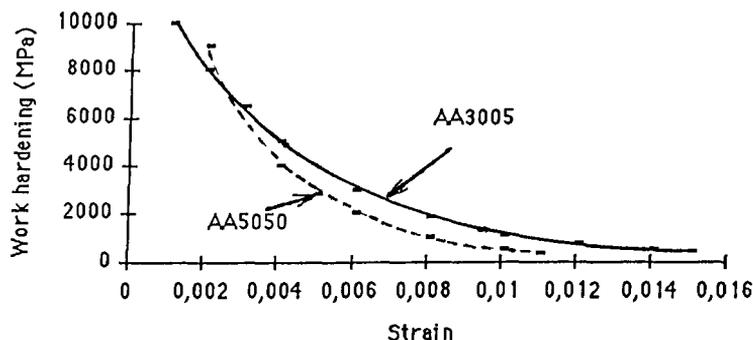
Fig. 4. The work hardening curves of AA3005 (H48) and AA5050 (H48) deep drawn to a compressive strain in the wall of 0.6.

The mechanical properties of the corner samples are presented in Table. 2. From these data, it is observed that the flow stresses have increased only slightly in AA3005 material and the elongations correspondingly a little reduced. On the other hand, AA5050 have increased substantially more in strength and the workhardening and elongations lowered. The workhardening is characterized by plotting  $d\sigma/de$  against the strain (Fig. 4). From these curves, it can be concluded that the AA3005 material has a better overall work hardening characteristics. Therefore, the distribution of strain will be more even and critical instabilities avoided [1].

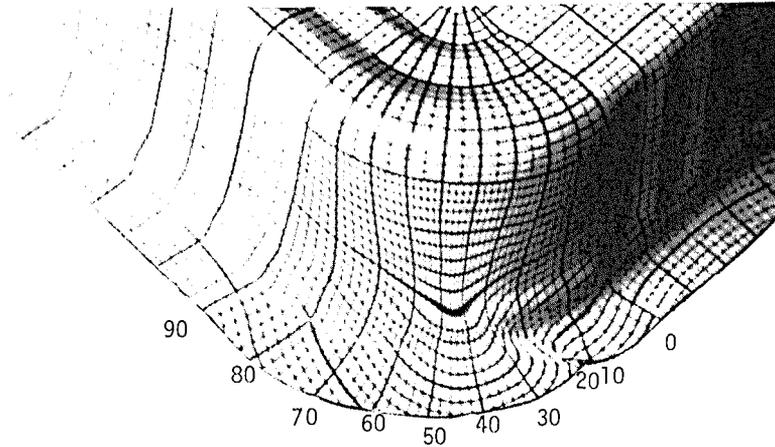
Fig. 5. Optical macro image of a fracture in the flange of AA5050 material. (The small squares are originally 1x1 mm.)

The defect is a shear fracture where the material from the short edge overlap the material from the corner (Fig. 5). The fracture runs into the flange. The early stage in the development is best seen after the first drawing operation (Fig. 6a) where an open V-shape have been formed apparently because the material around 20 ° has relative restricted flow in contrast to AA3005 where the change is gradual. (Fig. 6b). Turning the can of AA5050 material 90°, however, gave the same edge profile as AA3005.

After the second drawing operation, the V must have narrowed and from the grid pattern, it was found that the two legs of the V must have collided resulting in a shear fracture in the notch in this type of metal flow. The cause of the defects are therefore the anisotropic flow of the flange between 10-45°, but what is the underlying reason ?

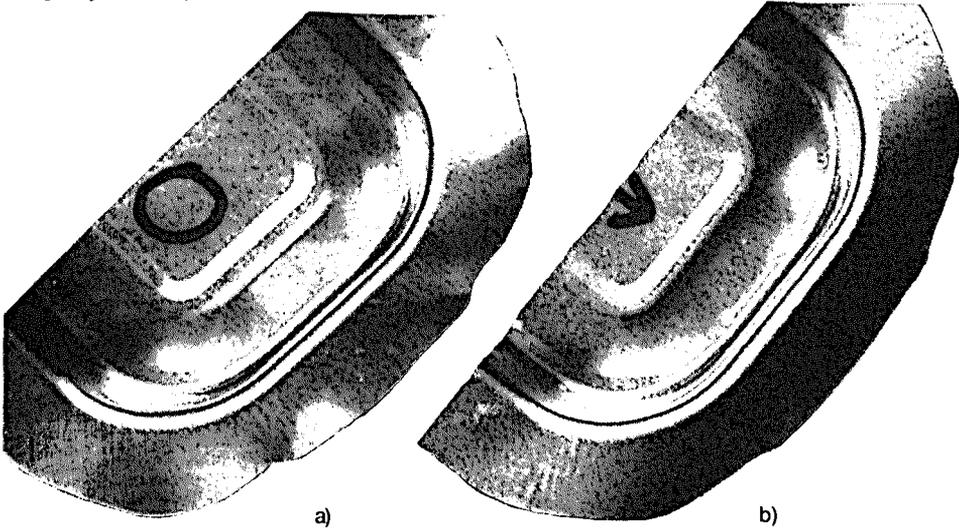
Fig. 6. Optical macroimage of the flange after the first drawing operation. a) AA5050 with rolling direction along the long edge of the can, b) the corresponding image using AA3005 material.
