THE 4TH INTERNATIONAL CONFERENCE ON ALUMINUM ALLOYS

EFFECT OF MICROSTRUCTURE ON THE FATIGUE CRACK PROPAGATION BEHAVIOR OF HIGH-STRENGTH AL-ZN-MG-CU ALLOYS

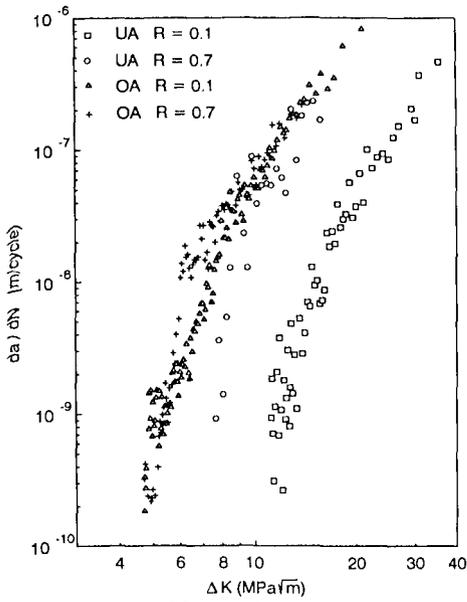
Fig. 1: X-7075, UA vs. OA, Vac.

The influence of degree of age-hardening on the fatigue crack propagation behavior in vacuum is shown in Fig. 1 for the equiaxed grain structure of X-7075, comparing under- and overaged conditions at R-ratios of 0.1 and 0.7. Crack propagation occurred in a transgranular manner along slip bands in both aging conditions up to growth rates of 10^{-6} m/cycle , independently of R-ratio. The results in Fig. 1 confirm the usually observed higher resistance against crack growth of the planar deforming underaged condition in comparison to the more homogeneously deforming overaged microstructure at low and high R-ratios. However, the underaged condition exhibited pronounced higher growth rates at the high R-ratio of 0.7 as compared to $R = 0.1$, while the overaged condition showed almost no effect by varying the R-ratio.

The observed higher resistance against crack growth of the planar deformed underaged as compared to the more homogeneously deformed overaged condition of X-7075 (Fig. 1) cannot be explained on the basis of fracture properties, which would lead to an opposite ranking (Table II), or with crack closure alone. For example, correcting the crack growth curves in Fig. 1 for the underaged and overaged conditions at $R = 0.1$ with the measured closure values, respectively, would not result in coinciding curves. It is thought therefore that the very tortuous crack front profile of the underaged (Fig. 2a) as compared to the almost flat profile (Fig. 2c) and smooth

contour (Fig. 3a) of the overaged condition seems to be mainly responsible for the observed ranking of these two crack growth curves in Fig. 1. The importance of crack front geometry variations is further illustrated by considering the higher crack growth resistance of the underaged as compared to the overaged condition at the high R-ratio (Fig. 1), where no closure was detected. It is thought that this higher resistance can be explained mainly by the more serrated crack front profile of the underaged (Fig. 2b) as compared to the overaged condition (Fig. 2d). Furthermore, the coinciding propagation curves (certainly by chance) of the overaged condition at low and high R-ratios (Fig. 1) are probably a result of the strikingly different crack profiles, being very flat at $R = 0.1$ (Fig. 2c) but changing to a rough profile at $R = 0.7$ (Fig. 2d), which obviously seems to counterbalance the normally observed higher growth rates at high R-ratios.

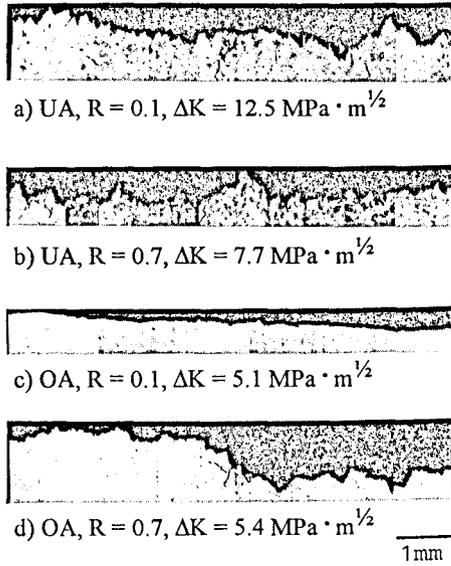
Fig. 2: X-7075, Crack profiles (LM), $da/dN = 10^{-9}$ m/cycle, Vac.

Examples of through-thickness crack front profiles at a constant propagation rate of 10^{-9} m/cycle are shown in Fig. 2, the crack growth direction being normal to the plane of these light micrographs. The crack front profiles of the underaged condition were found to be very serrated, exhibiting approximately the same roughness at low (Fig. 2a) and at high (Fig. 2b) R-ratios. In

contrast, the overaged microstructure revealed a very flat through-thickness profile at $R = 0.1$ (Fig. 2c) while at a high R-ratio of 0.7 the concomitant profile was found to be much rougher (Fig. 2d), however with more rounded off peaks and valleys as compared to the profiles of the underaged condition (compare Figs. 2b and d).

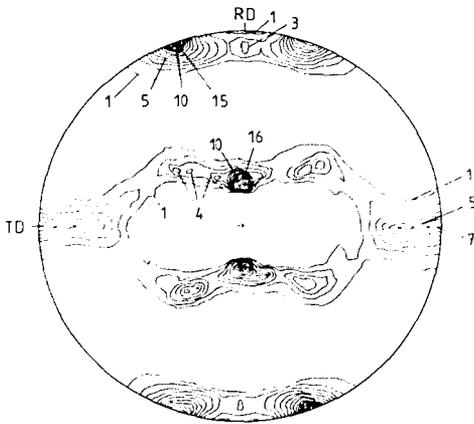
a) PCS
Fig. 6: 7475, UA, {111} Pole figures

The as-received commercial 7475 alloy exhibited after a solution heat treatment a pronounced pancake shaped grain structure (termed PCS), which was found to be unrecrystallized having a subgrain size of about $3 \mu\text{m}$ (7). This structure exhibited a very strong texture, shown in Fig. 6a as $\{111\}$ pole figure, the marked intensities being "times random". The major component of this texture can best be represented by $\{123\} \langle 412 \rangle$, while a minor component belongs to $\{011\} \langle 211 \rangle$. In contrast, the thermomechanical treated 7475 alloy showed a pronounced reduction in grain shape anisotropy (termed TMT) with almost completely recrystallized grains and a very weak texture (Fig. 6b).

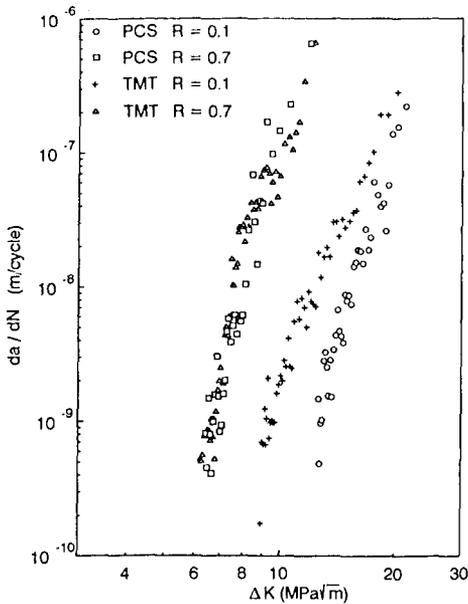
Fig. 7: 7475, UA, PCS vs. TMT, Vac.

The fatigue crack propagation behavior in vacuum of these two underaged microstructures of 7475 is shown in Fig. 7 for R-ratios of 0.1 and 0.7. Crack propagation was found to occur along slip bands in both grain structures. At $R = 0.1$ the highly anisotropic PCS structure showed a higher resistance against crack propagation in comparison to the less anisotropic TMT structure. At $R = 0.7$ this difference in propagation resistance disappeared, the growth curves lying on top of each other (Fig. 7).

Differences in crack closure levels are thought to explain mainly the observed higher crack growth resistance at $R = 0.1$ of the very anisotropic PCS structure of 7475 in comparison to the more equiaxed TMT structure (Fig. 7), together with a contribution of the somewhat rougher profile of the PCS structure (compare Figs. 2a and c). The higher closure of the PCS structure seems to be a consequence of the very strong texture (Fig. 6a), resulting in pronounced shear facets traversing mostly several pancake shaped grains (Figs. 8a and 9c), which is thought to contribute to a pronounced mode II shear displacement at the crack tip. On the other side, the TMT structure with the very weak texture (Fig. 6b) showed a more random orientation of slip band fracture (Fig. 9b) which obviously reduced the amount of mode II shear displacement. At the high R-ratio (no closure) both grain structures exhibited a similar crack growth resistance (Fig. 7), in accordance with the observed almost identical crack front profiles (Figs. 8b and d).

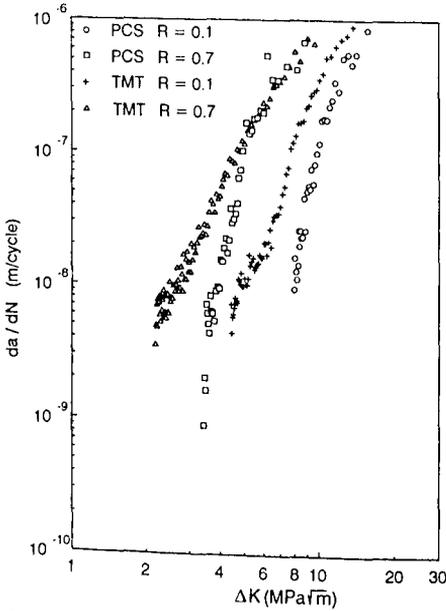
Fig. 10: 7475, UA, PCS vs. TMT, 3.5 % NaCl Sol.

The effect of a corrosive 3.5 % NaCl solution on the crack propagation behavior of the two different grain structures (PCS, TMT) of 7475 is shown in Fig. 10, again at R-ratios of 0.1 and 0.7. It can be seen that the anisotropic PCS structure exhibited a higher crack growth resistance (at least below 5×10^{-7} m/cycle) in comparison to the more equiaxed TMT condition, independently of R-ratio. It will be noticed that growth rates in the corrosive environment below about 10^{-8} m/cycle were difficult to measure, especially at low R-ratios, because of crack arrest.

The importance of the fracture properties on the fatigue crack growth resistance, besides other factors (including crack front geometry and closure), was clearly shown by testing the two different grain structures of 7475 in a corrosive NaCl-solution (Fig. 10). The higher resistance of the PCS as compared to the more equiaxed TMT structure, regardless of R-ratio, is thought to result mainly from the observed transgranular fracture mode along $\{100\}$ planes for the PCS structure (Fig. 12a), as a consequence of the loading axis being parallel to the long boundaries of the pancake grains, in comparison to a pronounced portion of grain boundary fracture together with fracture along $\{100\}$ planes for the more equiaxed TMT structure (Fig. 12b). The environmentally induced grain boundary fracture is thought to be even more brittle than the transgranular fracture along $\{100\}$ cleavage planes. In this case the low fracture properties in combination with the very smooth crack profiles (Figs. 11c and d) of the TMT structure result in much lower crack growth resistance as compared to the PCS structure (Fig. 10).
