THE 4TH INTERNATIONAL CONFERENCE ON ALUMINUM ALLOYS

IMPROVEMENT OF FATIGUE STRENGTH OF AA 7050 T7451

A. Heinz and W. Schelb

Hoogovens Aluminium Walzprodukte GmbH, Postfach 920, D-56009 Koblenz, Germany

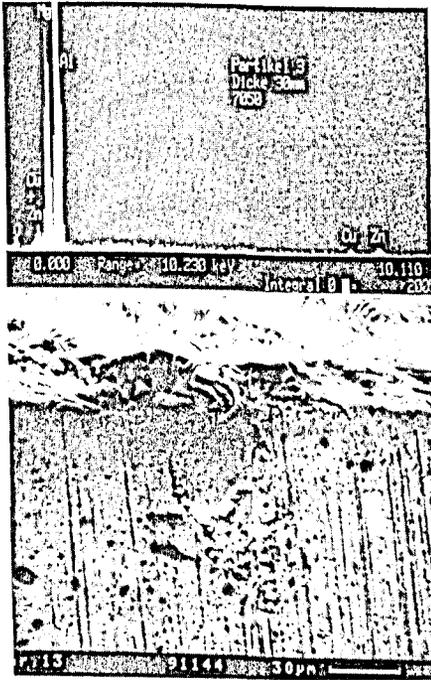
An example of crack initiation in thin material is given in Fig. 3. The lower part shows the fractured fatigue specimen with a non-conductive particle as the crack nucleation centre in the middle. The energy dispersive X-ray (EDX) analysis of this particle shown in the upper part of Fig. 3 reveals that failure was due to an oxide inclusion in this case.

Fig. 3: Crack initiation by an oxide inclusion in thin (30mm) 7050 T7451 plate material

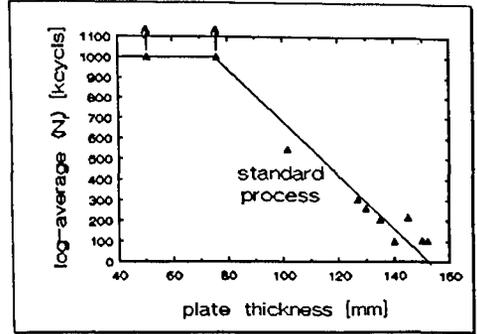
Fig. 4

Log-average fatigue life versus plate thickness in the gauge range from 50 to 152mm (2-6 inches) is shown in Fig. 4. The arrows indicate that fatigue tests were terminated at a maximum of 1,000,000 cycles if failure did not occur. Fatigue life decreases with increasing plate thickness. Obviously the crack initiation phase was accelerated dramatically by the micropores that were present in thick plate material. As the relevant gauge is above 100mm (4inches) it was decided to concentrate on the improvement of fatigue strength by suppressing microporosity in these thick sections.

Fig. 4: Influence of plate thickness on average fatigue life, standard production practice at the beginning of the project

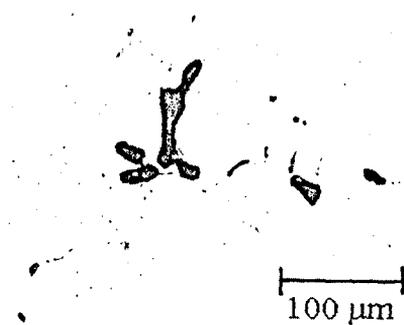
Fig. 5

An optical micrograph of a typical pore cluster as it is found in the as-cast structure is shown in Fig. 5. The individual pores of the cluster are presumably connected below the surface via interdendritic channels which are due to shrinkage during solidification. Fig. 6 shows the pore density as a function of pore diameter for three different locations within the cross-section of the ingot. The material was cast according to Hoogovens' standard casting process and the pore density was measured using optical microscopy. The detrimental influence of porosity on fatigue strength was expected to increase with increasing pore size. Therefore an arbitrarily chosen limit to assess the influence of location and processing variables on microporosity was defined which is represented by the vertical line at 80 μ m.

Fig. 5: Cluster of micropores in the as-cast structure of a 7050 ingot, standard casting process

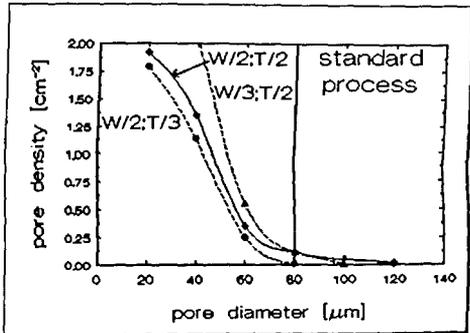
Fig. 6: Influence of position within the ingot cross-section on pore size distribution; W=width, T=thickness of ingot, standard casting process

It is obvious from Fig. 6 that the critical position within the ingot cross-section is the midplane (W/2-T/2/W/3-T/2) as remarkable porosity is found above 80μm. Outside the center plane porosity was less pronounced and no pores were measured above the assessment limit.

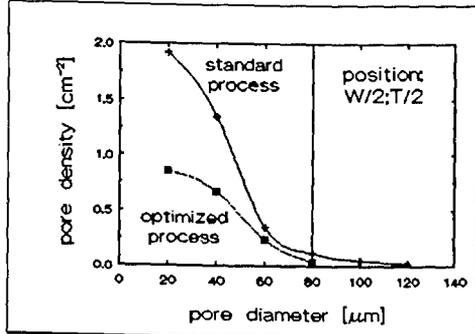
Fig. 7a: Microporosity is reduced by a modified casting process, optical microscopy

Fig. 7a shows that microporosity at the critical position could be reduced considerably by optimizing the process. Pore density could be decreased by a factor of two and - more important - no remaining porosity was detectable above 80μm. Fig. 7b shows a similar result which was obtained by acoustic microscopy on the same specimens as in Fig. 7a. Compared to optical microscopy the pore sizes are shifted to larger diameters. This is mainly due to the subsurface extension of the micropores which is not revealed of course by optical but by acoustic microscopy. Accordingly the assessment limit had to be shifted to a larger value for the acoustic microscopy. A further fact is that the densities of small pores are much larger when determined by acoustic microscopy. This is shown in Fig. 8, where the pore density measured by acoustic microscopy is plotted versus the pore density measured by optical microscopy. Large values of pore density refer to small pore diameters and vice versa. If the

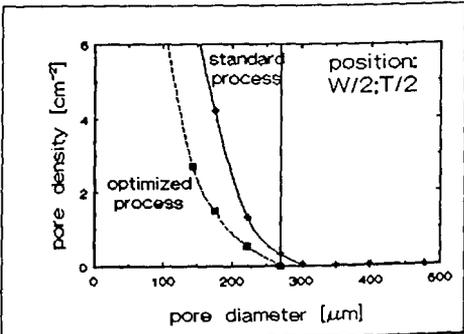
Fig. 7b

Fig. 7b: Same specimens as in Fig. 7a, but pore densities measured by acoustic microscopy

pore density exceeds a value of approximate 0.05 pores per square centimeter acoustic microscopy detects considerably more pores than optical. This is due to the fact that the acoustic microscope probes a 75 μ m thick subsurface layer and therefore measures a much larger number of pores provided that the diameters of these pores are below the thickness of the probed layer. If the diameter of the pores under consideration is larger than that thickness however both methods will give the same results. This can be seen in Fig. 8 for small pore densities which correlate to large pore diameters. As large pores are considered to be detrimental to fatigue strength both methods are essentially of the same relevance.

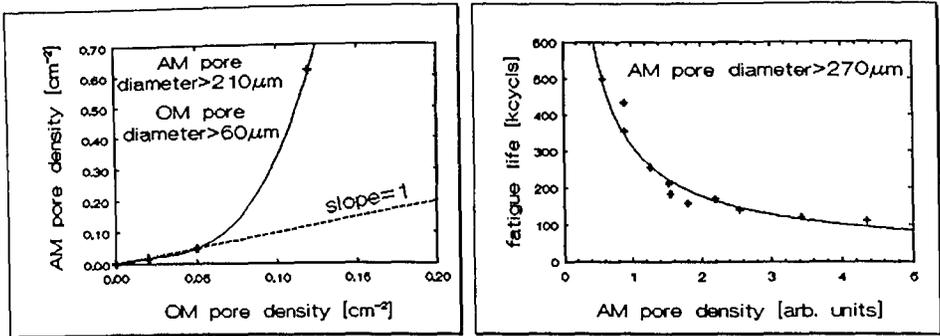
Fig. 8

Fig. 8: Pore densities measured by optical and acoustic microscopy

Fig. 9: Fatigue life of finished plate as a function of pore density in the as-cast structure, pore densities measured by acoustic microscopy

In order to calibrate fatigue performance of the finished plate against pore density in the as-cast structure a number of ingots were cast with varying defect densities and fabricated to 152 mm (6inch) thick plates. An exponential dependence of average fatigue life on pore density resulted (cf. Fig. 9). Fig. 9 allows also to deduce maximum values for microporosity in the as-cast structure for obtaining satisfying fatigue strength of the finished plate.

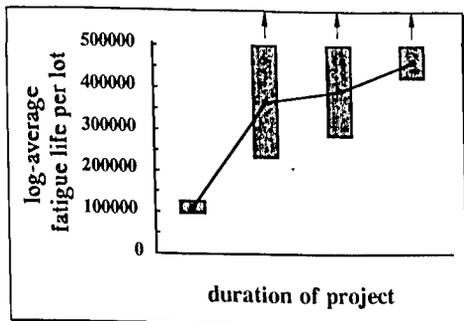
Fig. 10

The scatter of log-average fatigue life of 152mm (6inch) thick plates is plotted versus the duration of the project in Fig. 10. The arrows indicate that fatigue testing was terminated at a maximum of 500,000 cycles if failure did not occur. The left column represents the situation at the beginning of the project where average fatigue life was between 95,000 and 127,000 cycles. Step by step fatigue strength could be improved by taking into consideration further critical processing variables. The right column represents the optimized processing route. Its lower limit is 422,300 cycles, which is an improvement of +340% compared to 95,000 cycles from the beginning of the project.

Fig. 10: Improvement of average fatigue life per lot during the project

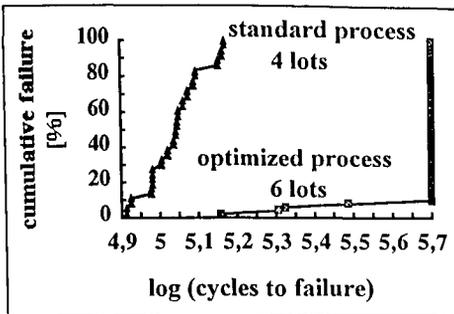
The achieved improvement is also demonstrated very impressively by Fig. 11 which shows the cumulative failure as a function of the logarithmic fatigue life for 152mm (6inch) thick plates. The plates were fabricated by either the standard (4 lots) or the optimized (6 lots) processing route. A value of 5.7 on the x-axis represents a fatigue life of 500,000 cycles which was the value to terminate the tests. The plates manufactured according to the standard procedure

exhibit a scatter of fatigue life between 80,000 and 150,000 cycles. The plates of the optimized process on the other hand show fatigue lives between 142,000 and at least 500,000 cycles. In fact only four of the tested specimens failed before half a million cycles and all others were runouts. These results were confirmed so far by a total of 18 production lots.

Fig. 11: Cumulative failure versus logarithmic fatigue life, standard and optimized process, almost all specimens of the optimized process were runouts at 500,000 cycles

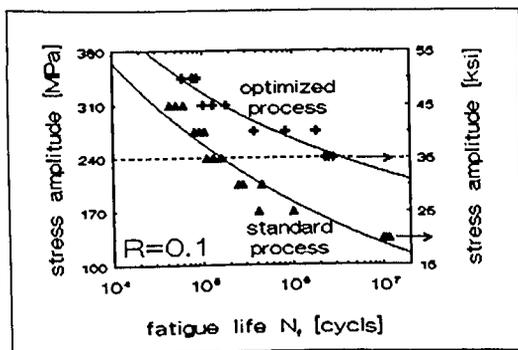
Finally, Fig. 12 shows the S-N-curves of both the standard and the optimized plate material (gauge: 152mm=6inch). The applied stress amplitudes range from 138 to 345MPa (20 to 50 ksi). At the required stress level of 241MPa (35ksi) the fatigue life could be improved from about 100,000 to at least 3 million cycles. For a given fatigue life of 100,000 cycles on the other hand the applied stress was considerably raised.

Fig. 12: S-N-Curves of 6in thick plates fabricated by the standard and the optimized process
