THE 4TH INTERNATIONAL CONFERENCE ON ALUMINUM ALLOYS

FATIGUE PROPERTIES OF AL 8090

H. Hargarter¹, G. Lütjering¹, J. Becker², and G. Fischer²

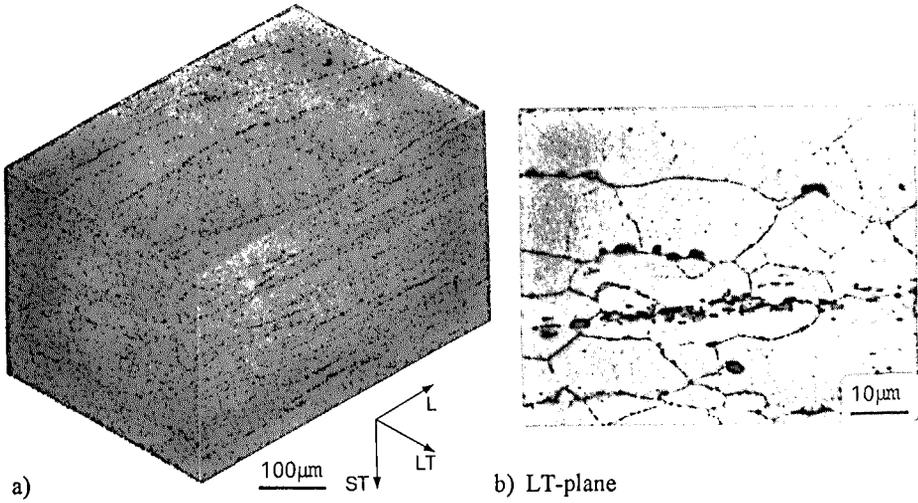
Fig. 1 - Microstructure (LM)

The microstructure of the alloy consisted mainly of the typical unrecrystallized pancake grains, which appeared fairly elongated in the L-direction (Fig. 1a). The grains had average dimensions of $50 \times 100 \times 1000 \mu\text{m}$ and contained low angle boundaries forming equiaxed subgrains with diameters of about 5 to 20 μm . In addition, large inclusions (Fe containing intermetallic particles) aligned in stringers in L-direction were found (Fig. 1b). The precipitate microstructure consisted mainly of coherent δ' -particles (Al_3Li) and semicoherent S'-plates, both homogeneously distributed throughout the matrix. Incoherent particles of the equilibrium phases were located along grain boundaries, leading to precipitate free zones.

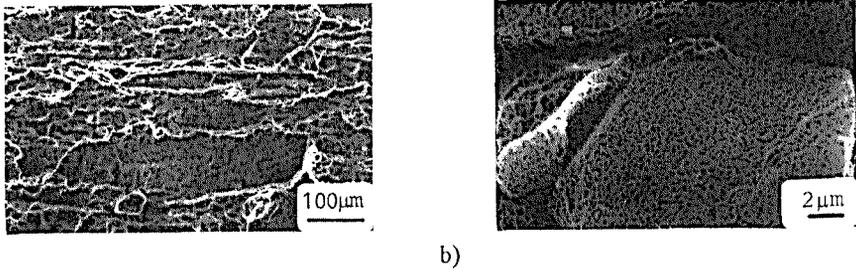
Fig. 2 - Tensile fracture surface (SEM)

The tensile properties are listed in Table 1. In the ST-direction especially the ductility was significantly lower than in the L-direction. In the ST-direction fracture occurred mainly along large angle grain boundaries, which on a local scale adopted part of the shape of the equiaxed subgrains (Fig. 2a). On the fracture surface sometimes "mats" of the Fe-containing inclusions were found, which contributed to the low ductility and the low fracture toughness (3). Higher magnifications revealed a ductile, dimpled type of fracture (Fig. 2b).

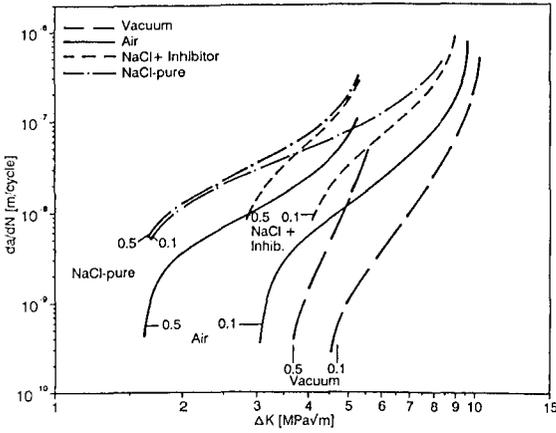
Fig. 3
Nominal da/dN - ΔK curves
for $R = 0.1$ and $R = 0.5$

The fatigue crack growth behavior in the different environments is shown in form of da/dN vs. ΔK -curves in Fig. 3 for both stress ratios. In the aggressive environments, including laboratory air, fatigue crack propagation occurred at substantially lower ΔK -values than in vacuum. At a propagation rate of approximately 1×10^{-9} m/cycle the difference between the curves of $R = 0.1$ and $R = 0.5$ was much more pronounced in air than in vacuum. The lowest resistance to fatigue crack propagation was observed for the pure chloride solution. In this environment little difference in the propagation behavior between stress ratios of 0.1 and 0.5 was found, whereas in the NaCl-solution containing inhibitors a distinct difference was observed. With inhibitors, higher ΔK -values were necessary for crack propagation at $R = 0.1$ than at $R = 0.5$. Also it proved to be impossible at the lower stress ratio to establish slower propagation rates than approximately 1×10^{-8} m/cycle. This was in contrast to the tests in pure NaCl-solution in which stable fatigue crack propagation occurred with substantially slower propagation rates. It is believed that for NaCl-pure the fatigue behavior could be studied at slower crack velocities than actually tested in this investigation.

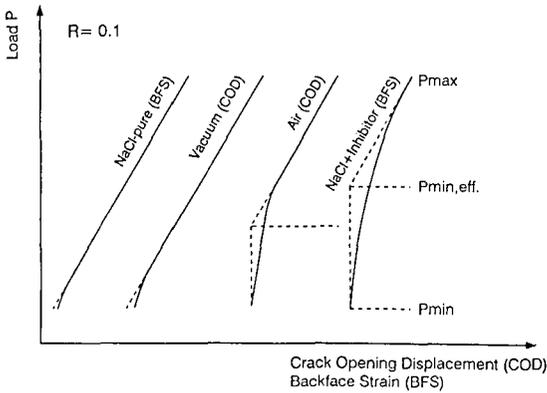
Fig. 4
Typical COD-curves from
tests at $R = 0.1$

Typical plots of load vs. displacement or back face strain (which was used for tests in the aqueous solutions) are compared in Fig. 4. At a stress ratio of 0.1 some nonlinearity was observed in all the curves indicating crack closure effects. The crack closure effects in vacuum and NaCl-pure were negligibly small. In laboratory air and in the chloride solution with inhibitors significant crack closure effects were present (Fig. 4). At the stress ratio of 0.5 only in the NaCl + inhibitor-solution measurable crack closure was found.

Closure corrected ΔK -values (ΔK_{eff}) were calculated by using $P_{min,eff}$ as indicated in Fig. 4. The resulting "effective" da/dN - ΔK curves are shown in Fig. 5. Due to closure three fatigue crack propagation curves are shifted considerably (laboratory air tested at $R = 0.1$ and the two curves tested in NaCl + inhibitors). Also the effective stress ratios are included as data points for these three curves in Fig. 5 because crack closure not only affects ΔK but results also in an increase of the actual stress ratios. In air, the effective stress ratio increased from 0.1 to approximately 0.3, due to closure. For the solution of NaCl + inhibitors, effective stress ratios increased from 0.1 to about 0.4 and from 0.5 to about 0.6.

In vacuum any environmental effects are absent. Since only very little crack closure was found (Fig. 4) and since the crack front profiles were identical for both stress ratios (Fig. 6), crack closure cannot account for the difference between the curves tested at $R = 0.1$ and $R = 0.5$. At a given ΔK , the maximum stress intensity is much higher in case of the higher stress ratio and results in enhanced fatigue crack propagation rates. For both stress ratios a retarding contribution to fatigue crack propagation in vacuum can be deduced from the serrated crack front geometry observed.

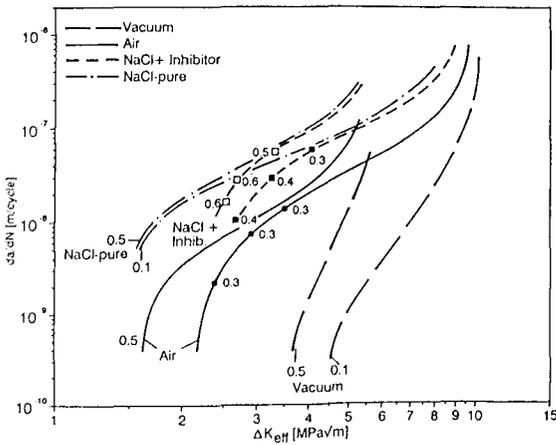
Fig. 5
Closure corrected da/dN - ΔK
curves. Data points indicate
the effective stress ratios

In air the pronounced closure effect seems also to result mainly from the fracture surface reaction products, since the crack front geometries were similar in air and the chloride solutions. The remaining difference after closure correction between the curves at low and high R-values indicate some influence of K_{max} (Fig. 5), similar to the behavior in vacuum.

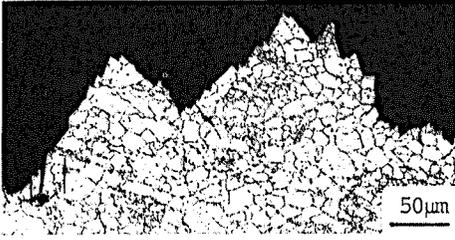
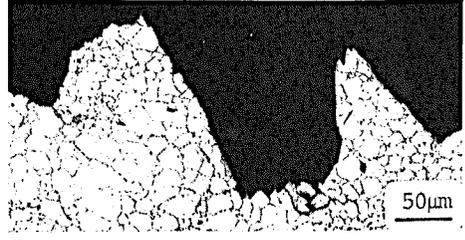
a) $R = 0.1$

b) $R = 0.5$

Fig. 6 - Crack profiles at $da/dN = 1 \times 10^{-8}$ m/cycle in vacuum

The crack front profiles were investigated on every specimen at selected crack velocities by sections perpendicular to the propagation direction. A very pronounced difference in roughness was found between vacuum and the other environments. In vacuum, at both stress ratios a rough crack front profile developed already at low ΔK -values, with only little change with rising ΔK (Fig. 6). No single portion of the profiles appeared to be orientated normal to the loading axis. In all other environments rather flat crack front profiles developed (Fig. 7-9), with no significant difference in surface roughness between the specimens tested at $R = 0.1$ and $R = 0.5$. Compared at equal crack velocities all aggressive environments resulted in the same profiles.

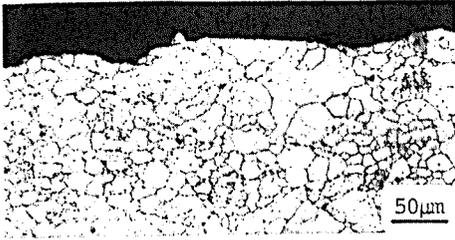
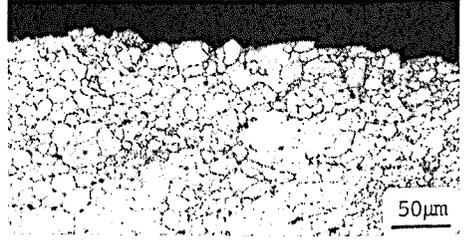
a) $R = 0.1$

b) $R = 0.5$

Fig. 7 - Crack profiles at $da/dN = 1 \times 10^{-8}$ m/cycle in air

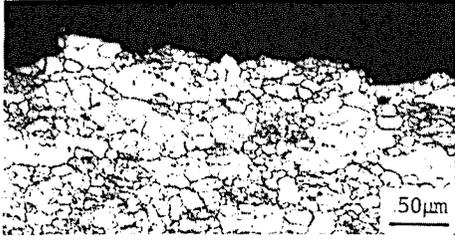
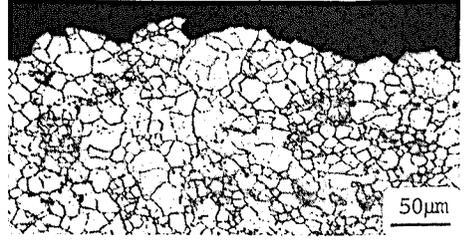
a) $R = 0.1$

b) $R = 0.5$

Fig. 8 - Crack profiles at $da/dN = 1 \times 10^{-8}$ m/cycle in NaCl + inhibitor solution

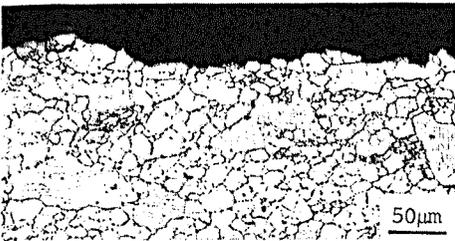
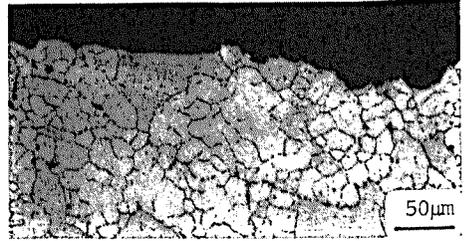
a) $R = 0.1$

b) $R = 0.5$

Fig. 9 - Crack profiles at $da/dN = 1 \times 10^{-8}$ m/cycle in NaCl-pure solution

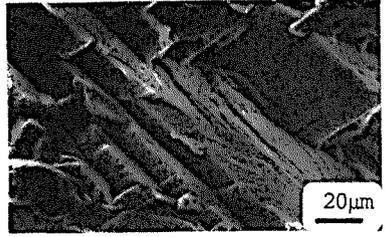
a) $R = 0.1$, $da/dN = 1 \times 10^{-8}$ m/cycle
Fig. 10 - Fatigue fracture surface (SEM), vacuum

b) $R = 0.1$, $da/dN = 1 \times 10^{-9}$ m/cycle

The fracture surfaces were also investigated and examples are shown in Figs. 10-13. Fig. 10 demonstrates the highly tortuous and faceted fracture surface of specimens tested in vacuum. The fracture mode clearly was crystallographic, as could also be concluded from the profiles of Fig. 6. In air, a mixed fracture mode was observed. At high propagation rates the fracture surface was dominated by a slip band fracture mechanism. At intermediate propagation rates of approximately 1×10^{-8} m/cycle fracture occurred mainly along large angle grain boundaries (Fig. 11a). With decreasing propagation rates an increasing part of the fracture surface consisted of areas with transgranular fracture (Fig. 11b). In contrast to the facets formed in vacuum experiments, these areas were always orientated normal to the loading axis (see also Fig. 7a). In both NaCl-solutions crack propagation almost completely occurred as a brittle type of grain boundary fracture (Fig. 12 and 13). Some amount of transgranular fracture was observed at crack velocities below 1×10^{-8} m/cycle (Fig. 13b) and had a similar appearance like in air (Fig. 11b).

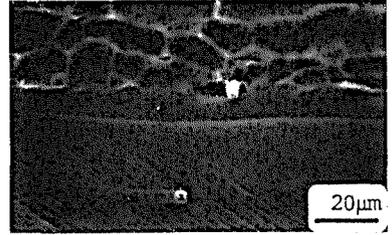
a) $R = 0.1$, $da/dN = 1 \times 10^{-8}$ m/cycle
Fig. 11 - Fatigue fracture surface (SEM), air

b) $R = 0.5$, $da/dN = 1 \times 10^{-9}$ m/cycle

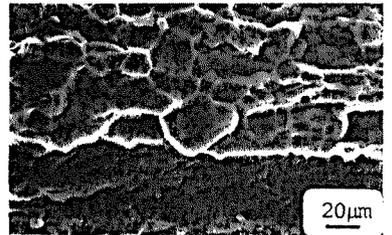
a) $R = 0.1$, $da/dN = 5 \times 10^{-8}$ m/cycle
Fig. 12 - Fatigue fracture surface (SEM), NaCl + inhibitor solution

b) $R = 0.1$, $da/dN = 5 \times 10^{-8}$ m/cycle

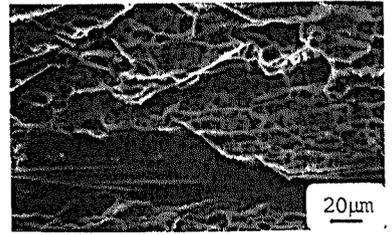
a) $R = 0.1$, $da/dN = 1 \times 10^{-8}$ m/cycle
Fig. 13 - Fatigue fracture surface (SEM), NaCl-pure solution

b) $R = 0.1$, $da/dN = 1 \times 10^{-8}$ m/cycle
