## Study on Crack Branching of 2324-T39 Aluminum Alloy under Tension Dominated Spectrum Loading

Fatigue crack growth test of aluminum alloy 2324 was conducted with middle crack tension specimen in L-T orientation under truncated loading spectra. Since it is the case of sheet loaded uniaxially and tension dominated, the crack was expected to appear flat in global scale and normal to the loading direction. It is true for the low truncation level cases, however, significant crack branching was observed during the tests under high truncation levels. The factors which tends to result in crack branching are studied. Macro and Micro level investigation show that: 1) there are little inclusion in the alloy, therefore, the branching is not caused by the lack of homogeneity; 2) the appearance of crack branching has close relation with the tension overload although it cannot be observed immediately after the peak load; 3) the growth of subsurface secondary crack under high truncation levels is the main reason for surface crack branching, the occurrence of the secondary crack results from the tension overload, while the growth of the secondary crack depends on the interval of two peak loads.

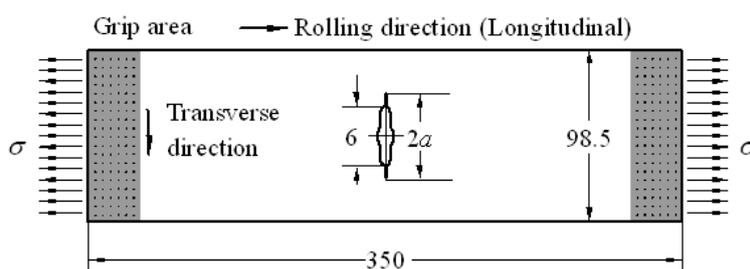
The FCG test was conducted with middle-crack tension, M(T), specimen. The configuration of the specimen is given in Fig.1. All the specimens are in L-T orientation, i.e. the applied external load is along the longitudinal (rolling) direction and the crack propagates along the transverse direction.

Fig.1 Configuration of the M(T) specimen (mm)

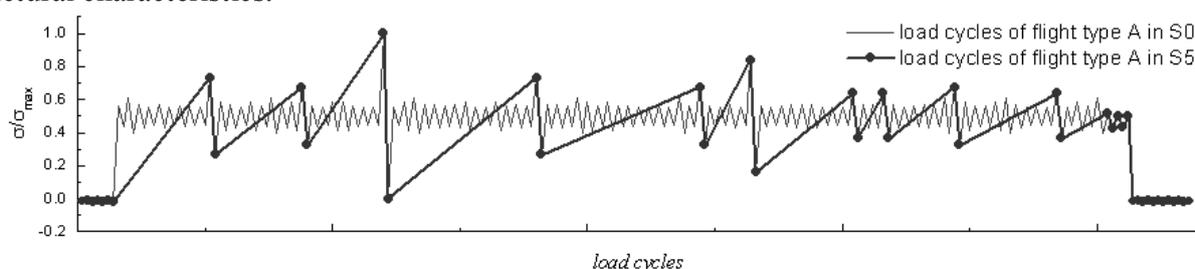
Six kinds of load spectra are employed in the FCG tests. The baseline load spectrum is a flight-by-flight spectrum containing five flight types arranged randomly within each load block. The baseline spectrum (S0) was filtered by removing small stress range cycles to obtain different truncated spectra. There are five truncation levels, 9.82%, 11.72%, 13.98%, 17.11% and 21.36%, resulting in five different truncated load spectra, named as S1, S2, S3, S4 and S5. A 9.82% truncation level indicates that those load cycles with stress range less than 9.82% of the maximum stress range in the S0 were removed, while the other parts of the spectrum were kept unchanged. The eliminated cycles in each loading block corresponding to the five truncation levels are 26.56%, 46.87%, 62.95%, 73.35% and 78.58% respectively. Segments of the loading cycles corresponding to the baseline

spectrum and the 5<sup>th</sup> truncation level are illustrated in Fig. 2. Both the baseline and truncated spectra are dominated by tension loads. The FCG tests were accomplished using the MTS 880 fatigue test system.

Fig.2 Segment of baseline and truncated loading spectrum

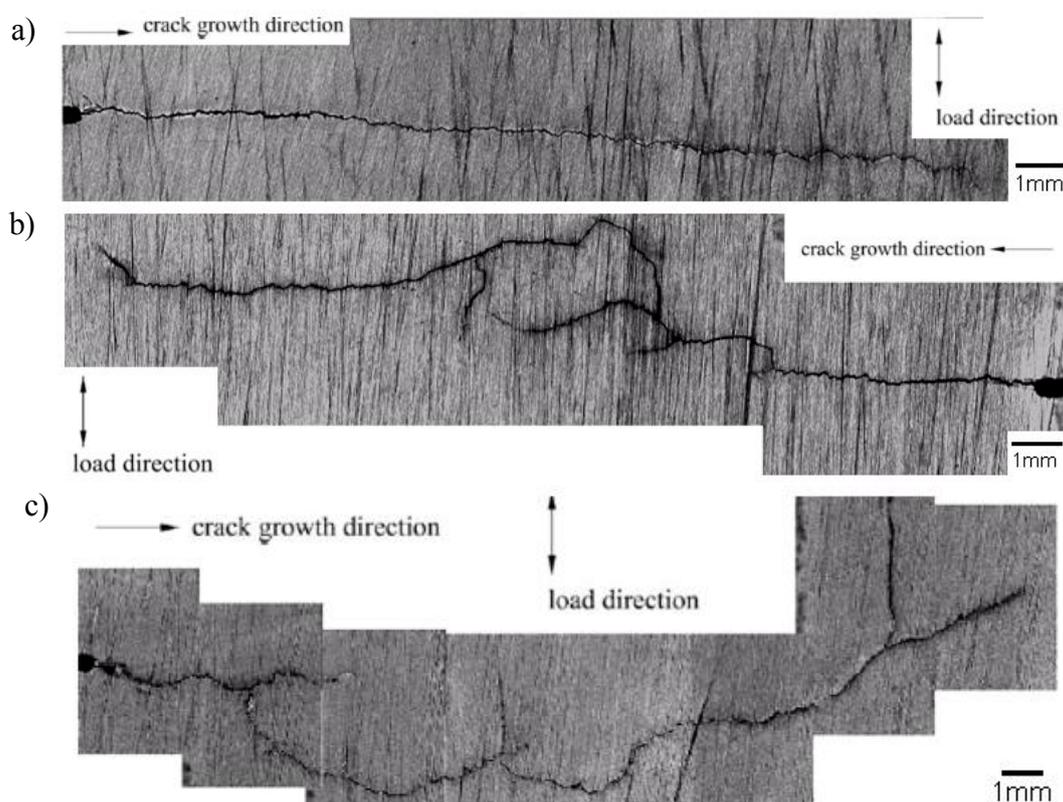
It has been observed during the experiment that cracks subjected to the baseline load spectrum S0 and low truncation level S1, S2 and S3 are perfect mode I cracks which are flat and straight and perpendicular to the applied loads direction. A typical mode I crack occurred under spectrum S1 is illustrated in Fig. 3(a). However, significant crack meandering and/or branching are observed when the low-load range truncation is increased to a certain level, i.e. S4 and S5. A typical branched crack occurred under spectrum S4 and S5 is illustrated in Fig. 3(b) and (c).

Fig. 3 Macroscopic crack morphology under (a) low truncation level S1, (b) high truncation level S4 and (c) S5

M1 is the specimen tested under S1 with truncation level of 9.82%. The crack, Fig. 3 (a), is flat in global scale and basically perpendicular to the applied tension load. The fracture surface under SEM shows typical fatigue failure characteristics, i.e. the striations as shown in Fig. 6 (a). Secondary cracks has been observed in Fig. 6(a), however, the secondary cracks remain in subsurface during the whole crack propagation procedure showing no influence on the global crack morphology.

the crack on left hand side show remarkable branching which is no longer perpendicular to load direction, moreover, some of the branches are parallel to the applied tension load, see Fig. 3(b). Examination of the fracture surface of the branched side with SEM, Fig. 6(b), shows large areas containing plastic zone, having their edges with secondary cracks. These subsurface secondary cracks grow to the specimen surface leading to the macro-level crack branching. The growth of the main crack shows typical fatigue fracture feature. Fig. 6(c) shows the intersection of the plastic zone edges with the main crack, which results in the combined features of fatigue and ductile fracture.

M3 is the specimen tested under spectrum S5 with truncation level of 21.36%. Significant crack branching, Fig. 3(c), on both the sides of the middle crack was observed on the surface of the specimen during the FCG test. SEM investigation of the fracture surface shows combined fatigue and ductile fracture features, similar to the left hand side of M2.

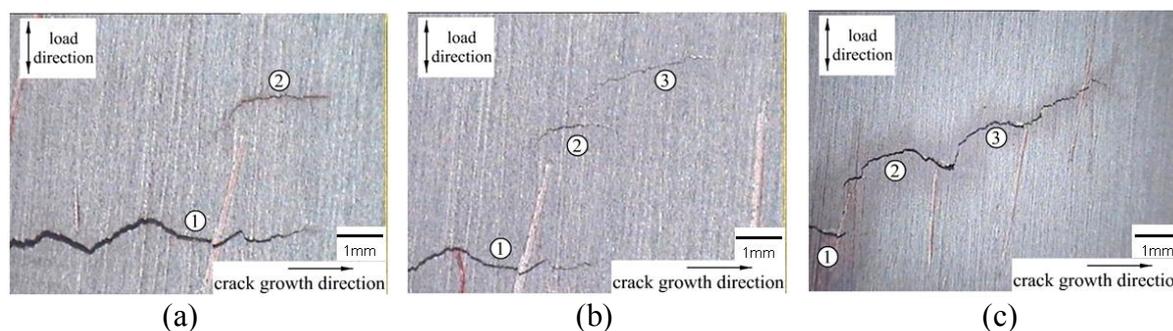
The significant crack branching is not resulted directly from the propagation of small branched crack. Surface secondary cracks were observed during the experiments and both the lead crack and the secondary cracks kept growing for a period of loading cycles until linked up, which has resulted in the observed remarkable crack branching. The appearance of the surface secondary cracks and the linking up process are shown in Fig. 4. No evidence shows that the surface secondary cracks initiate from the surface defects, they may raise from the growth of the subsurface secondary cracks.

Fig. 4 Appearance of secondary surface cracks and cracks linking up

From the aforementioned macro and micro investigations, it is clear that: 1) macroscopic crack branching was not initiated from the surface of the specimen (see Fig. 4); 2) surface crack branching is resulted from the coalescence of the main crack with the subsurface secondary crack which keeps growing to the specimen surface; 3) the existence of subsurface secondary crack is irrespective to load truncation level; 4) the difference is that secondary crack remains in subsurface under low truncation levels, on the contrary, it grows to the specimen surface under high truncation levels. The difference in load history of low and high truncation levels is that the loading cycles between the two peak tension load points. The loading cycles between the two peak loads are 197513, 71683 and 57593 for S1, S4 and S5, respectively. The value of the peak loads in all the load spectra is the same.

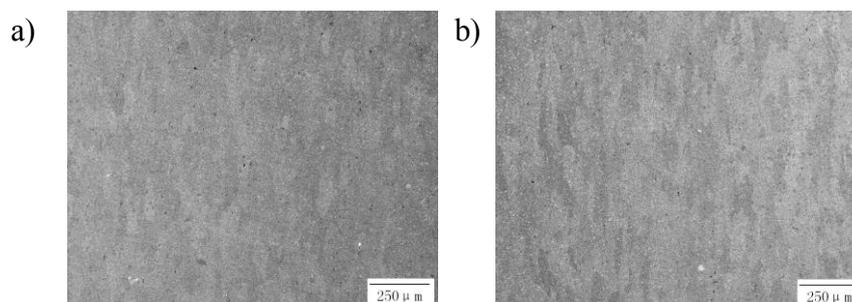
The micro structure inspection is aiming to find out if the homogeneity is the reason for crack branching. Two specimens are studied here, one is tested under S1 with no crack branching (in Fig. 3a), the other is tested under S5 with significant crack branching (in Fig. 3b). Fig. 5 (a) and (b) are the pictures taken by optical microscope for the two specimens, respectively. It can be seen from Fig. 5 that there is no noticeable difference in homogeneity of the two specimens. Therefore, the branched cracks are not caused by inhomogeneity of the material.

Fig.5 Micro structure of the two specimens (a) tested under S1 with no crack branching; (b) tested under S4 with significant crack branching

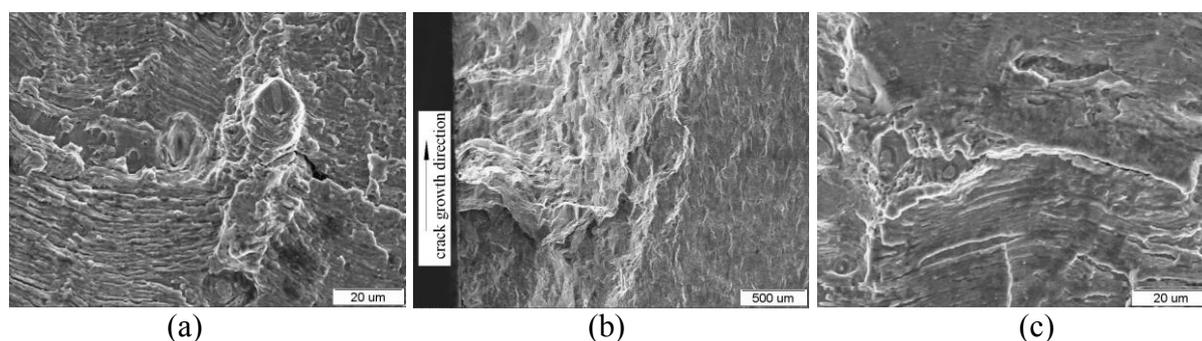
Fig. 6 Fractographic results of the specimens (a) tested under S1; (b) tested under S4; (c) tested under S5.

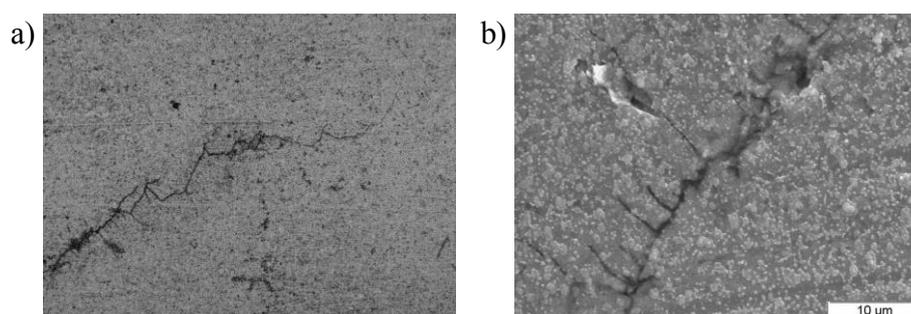
The surface of the specimen was scanned with optical microscope and SEM to identify the fracture mode of the branched crack as shown in Fig. 7. The main crack is typical transgranular fracture, while the branches show transgranular or transgranular shear fracture features.

Fig. 7 Microscopic fracture features observed by (a) optical microscope and (b) SEM
