Bendability and Fracture Behaviour of Heat-treatable Extruded Aluminium Alloys

Ida Westermann¹, Knut Erik Snilsberg², Bjørn Holmedal², Odd Sture Hopperstad¹
and Knut Marthinsen²

Keywords: Heat-treatable alloys, three-point bending, fracture

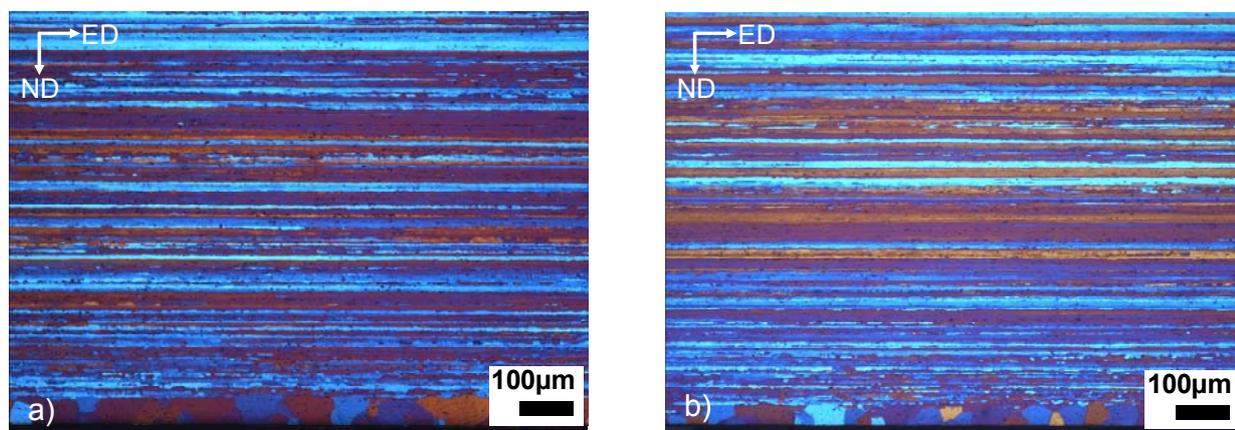
Both the alloys investigated have a fibrous microstructure with a recrystallized surface layer. For comparison the microstructure of the as-extruded alloys is shown in Fig. 1. The grain structure is similar in both, except that the surface layer of the AA7003 alloy in a) is somewhat thicker than for the AA7108 alloy in b).

Fig. 1 Microstructure of the as-extruded material. a) AA7003 and b) AA7108. Both are showing a fibrous structure with a recrystallized surface layer.

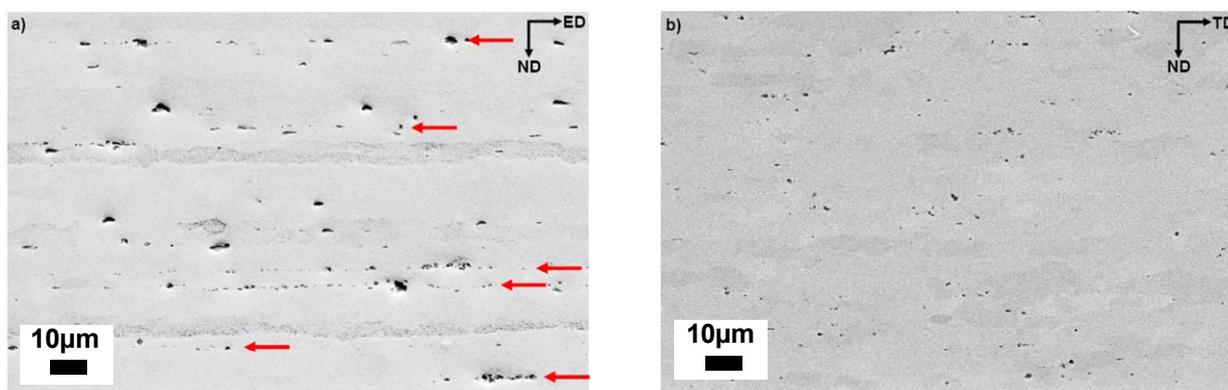
The distribution of primary particles in the profiles is expected to be equal for the two alloys and is influenced by the extrusion process. The AA7003 alloy was investigated by SEM analysis with respect to the distribution of primary particles. Fig. 2 a) shows how the particles align like beads on a string, indicated by arrows, along the extrusion direction in the ND-ED plane. However, in the ND-TD plane the particles are more randomly distributed, i.e. the strings are perpendicular to this plane, see Fig. 2 b).

Fig. 2 Distribution of primary particles in an AA7003. In a) the particles are clearly aligned along the extrusion direction, while the particles are more randomly distributed in the TD-ND plane in b).

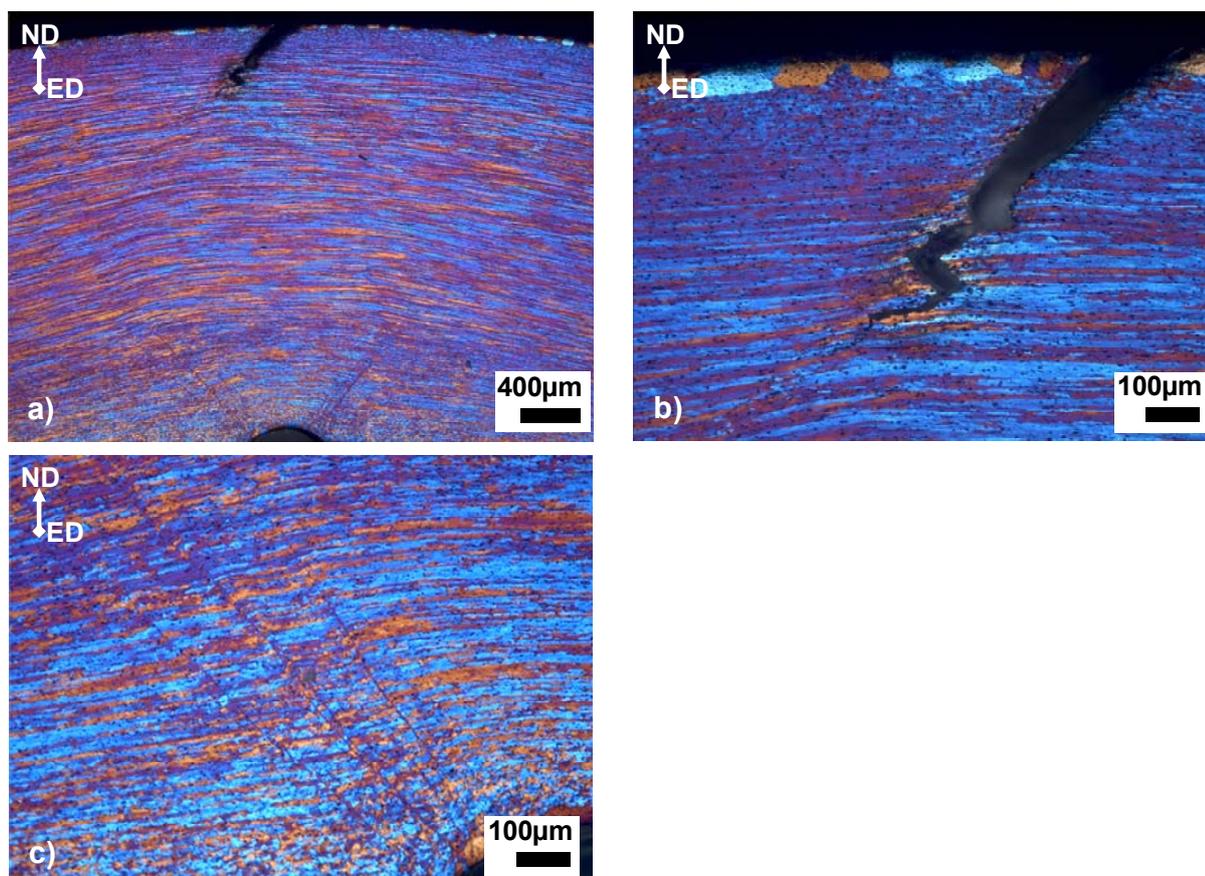
Fig. 1 Micrographs of the underaged AA7108 deformed with the bending axis along the extrusion direction: a) through-thickness overview, b) the crack propagation on the tension side and c) intense shear band formation on the compression side are seen.

The crack propagation was examined in the AA7108 alloy deformed by three-point bending for both the underaged and overaged conditions and with the bending axes along the ED and the TD. Fig. 3 and Fig. 4 show the microstructure of deformed underaged and overaged materials, respectively, when the bending axis is aligned with the ED. A closer look at the crack on the tension side in Fig. 3 b) reveals that the fracture at the surface of the sample is a transcrystalline shear fracture, and further into the material it turns into a mixture of intercrystalline and transcrystalline crack growth. On the compression side of the deformed sample, intense shear band formation is observed symmetrical around the bending axis, see Fig. 3 a) and c).

There is no doubt that strain localization in the form of shear band formation is the major failure initiation mechanism in three-point bending. Both Dao and Li [3] and Sarkar et al. [4] have concluded that roughening and grooves at the surface, typically at grain corners, work as initiation spots for the shear bands. Larger grain boundary precipitates have also been reported to cause initiation of shear banding inside the materials [3], which may explain the high density of deformation bands observed in the overaged condition in Fig. 6 b), where a coarsening of grain boundary precipitates is expected. A crystal-plasticity-based model for studying strain localization during bending has been presented by Dao and Li [3]. They have compared the effect of random texture and a typical deformation texture as well as the effect of a random distribution of particles. They found that the deformation texture increased the surface roughening and thereby increased the probability of shear band formation. This complies with the simulations made by Kuroda and Tvergaard [5] who have been studying the influence of the different texture components. Where Dao and Li have not taken into account the difference in bending axis, Kuroda and Tvergaard have included this in their investigation. They found that shear band formation on the compression side was more extended with the bending axis along the rolling direction for typical deformation textures. This is in agreement with the observations in the current work, where intense shear bands are seen on the compression side when the bending axis is aligned with the ED for both the tempers, Fig. 3 and Fig. 4. However, these shear bands on the compression side do not cause the material to fail.

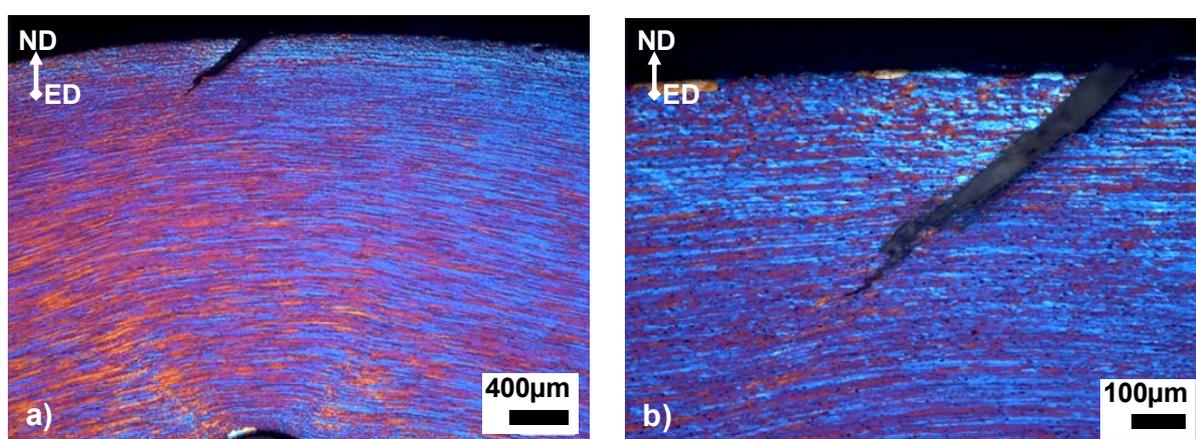
For the overaged condition with the bending axis in the ED, Fig. 4, the same trend is found as for the underaged condition. On the compression side intense shear bands are seen, Fig. 4 a). The fracture on the tension side has started as transcrystalline shear fracture at the surface and has turned into a combination of intercrystalline and transcrystalline crack growth as shown in Fig. 4 b).

Fig. 2 Micrographs of the overaged AA7108 deformed with the bending axis along the extrusion direction: a) through-thickness overview showing intense shear band formation on the compression side and b) crack propagation on the tension side.

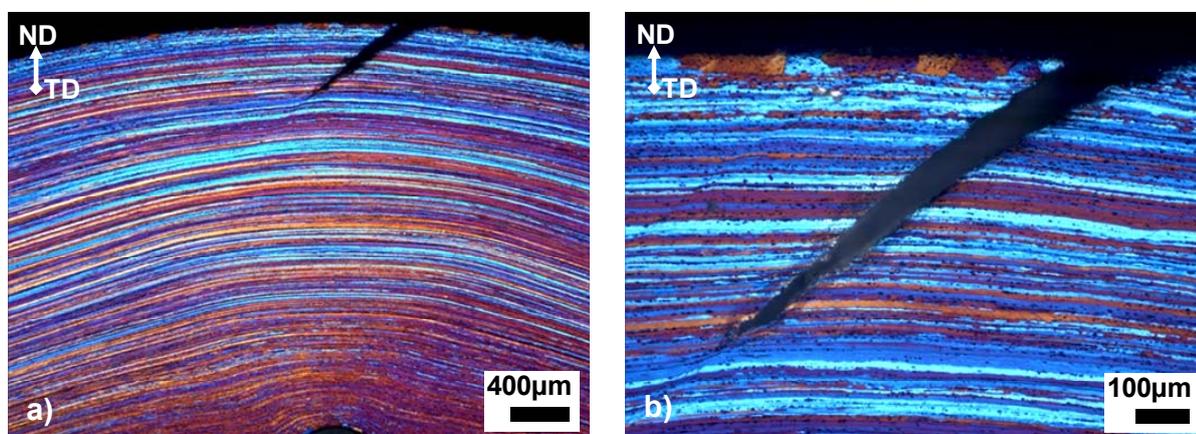
In Fig. 5 and Fig. 6 the crack propagation of the underaged and the overaged condition are shown, respectively, when the bending axis is aligned with the TD. None of these show shear band formation on the compression side. For both conditions the fracture on the tension side of the samples is a transcrystalline shear fracture. For the underaged condition only few shear bands are observed which are intense and narrow, Fig. 5 b), compared to the overaged condition, where deformation bands are seen in all the grains and the crack tip is broader, see Fig. 6 b).

Fig. 3 Micrographs of the samples deformed with the bending axes along the transverse direction for the underaged condition: a) through-thickness overview and b) crack propagation in the shear band on the tension side.

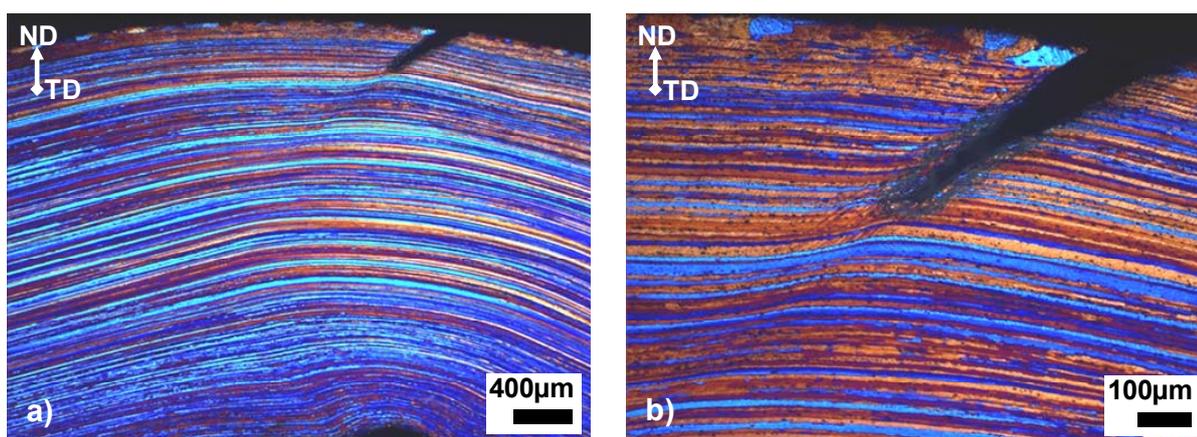
Fig. 4 Micrographs of the samples deformed with the bending axes along the transverse direction for the overaged condition: a) through-thickness overview and b) crack propagation in the shear band on the tension side and deformation bands.
