THE 4TH INTERNATIONAL CONFERENCE ON ALUMINUM ALLOYS

STRESS CORROSION CRACK PROPAGATION IN ALUMINIUM ALLOY 7150

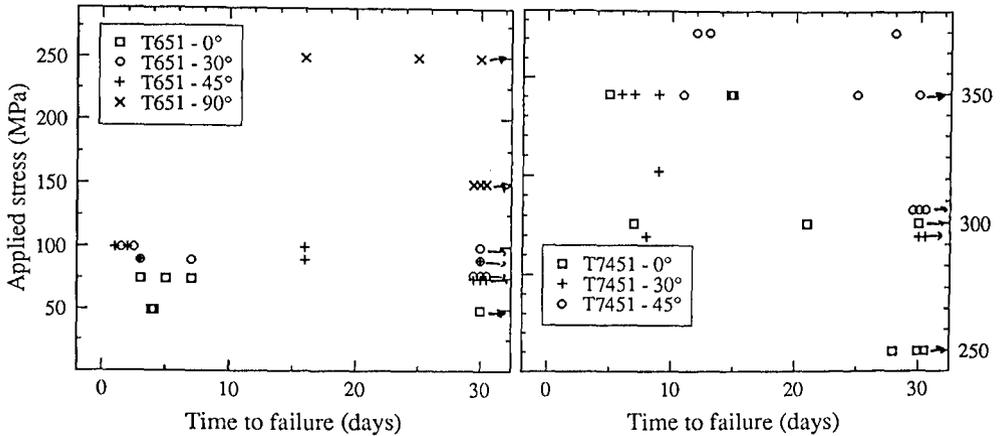
Figure 1. Applied stress versus time to failure for 7150-T651 and 7150-T7451 alloys for specimens cut at 0°, 30°, 45°, and 90° (LT) to the ST direction of 38 mm plate.

The times to failure in the constant load experiments for the four specimen orientations are shown in figure 1. Estimations of SCC threshold stresses that can be deduced from these data are plotted as a function of specimen orientation in figure 2. The most sensitive direction to SCC is, as expected, the ST direction. For both tempers the threshold stresses are slightly greater at 30° and 45° with respect to the ST direction and then increase to considerably higher levels in the LT direction. The correlations between the estimated thresholds at 0-45° and a fitted $\sigma(0^\circ)/\cos\theta$ curve are good for both T651 and T7451 tempers (on the assumption, thus, that the resolved stress in the direction perpendicular to the crack propagation plane, in this case the ST direction, controls crack propagation).

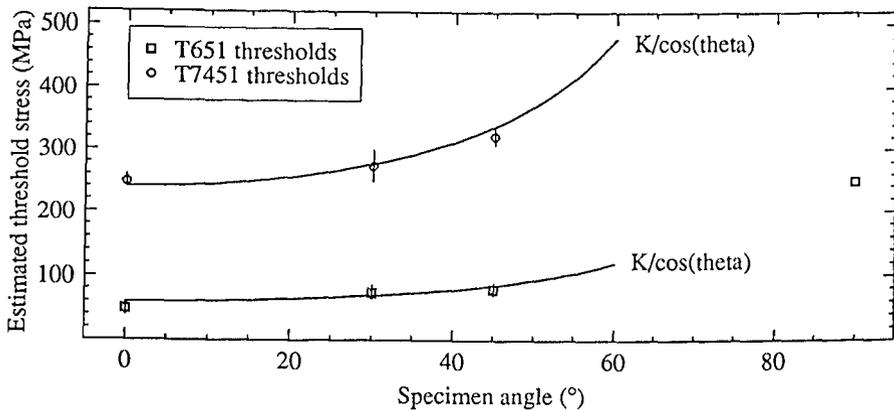
Figure 2. Estimated threshold stresses as a function of specimen orientation. The 0-45° thresholds appear consistent with a fitted $\sigma(0^\circ)/\cos\theta$ curve for both T651 and T7451 tempers, i.e. with the assumption that the resolved stress in the ST direction controls crack propagation.

limited number of regions features such as that shown in figure 6, which are clearly different from those observed in the standardised experiments. The steps visible in this micrograph are consistent with a transgranular propagation of the stress corrosion crack by hydrogen embrittlement (compare with e.g. [11]). The resistance to SCC in continuous immersion after pre-exposure, at a load above the estimated threshold stress in the alternate immersion experiments (see figure 2), reflects the increased susceptibility to stress corrosion in alternate immersion testing.

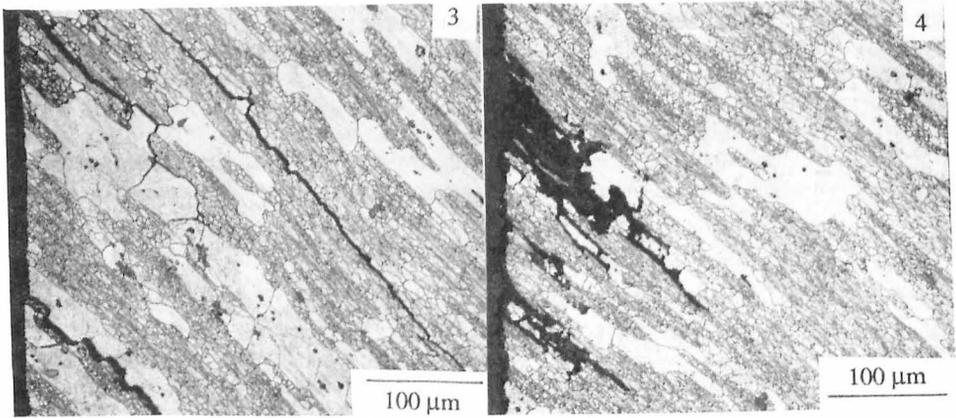
Figure 3. Cross-sectional optical micrograph in the LT-ST plane showing SCC in a T651 specimen cut at 45° to the ST direction. The crack propagation in the L-LT plane is characteristic of the 0-45° specimen orientations (chromic etch).

Figure 4. Cross-sectional optical micrograph in the LT-ST plane showing SCC in a T7451 specimen cut at 45° to the ST direction. The crack propagation in the L-LT plane is characteristic of the 0-45° specimen orientations (chromic etch).

Corresponding cross-sectional optical micrographs at 45° to the ST direction in the ST-LT plane are presented in figures 3 and 4 for the T651 and T7451 tempers respectively. Irrespective of temper or specimen angle, it is clear that on an optical scale crack propagation takes place at grain boundaries in the L-LT plane. The presence of sub-grain boundaries that are mechanically

favourably oriented does not alter the crack propagation direction. The crack tips are considerably finer in the T651 specimens than in the T7451 specimens. Moreover, many cracks of lengths greater than 200 μm were observed along the lengths of the T651 specimens, consistent with the very low resistance of this temper to SCC.

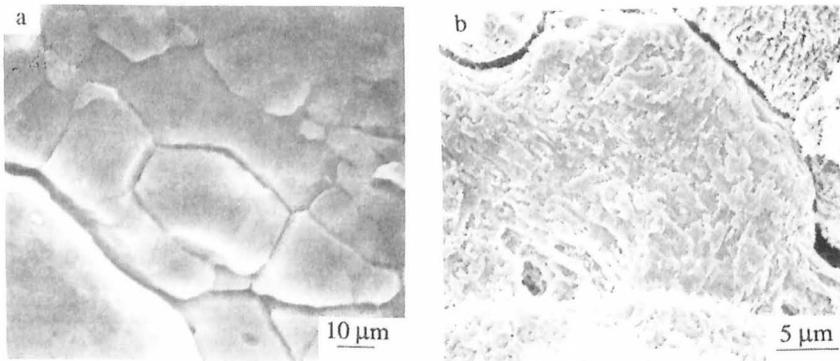
Figure 5. Characteristic SEM micrographs of fracture surfaces in the (a) T651 and (b) T7451 tempers of specimens cut in the ST direction. Note the brittle intergranular crack propagation with inter-subgranular corrosive attack for the T651 temper, and faceting characteristic of acid attack in the T7451 temper.

SEM micrographs of regions characteristic of the environmentally-induced cracking at all angles except 90° are presented in figures 5a and 5b for the T651 and the T7451 tempers respectively. The fracture surfaces are indicative of failure at or near grain boundaries. On the T651 specimens, the fracture surface is decorated with subsidiary cracks that are consistent with inter-sub-granular corrosion after passage of the primary stress corrosion crack (see figure 5a). These

are less frequent for the T7 temper, the fracture surface of which shows surface faceting indicating generalised corrosion in an acid environment after passage of a stress corrosion crack.

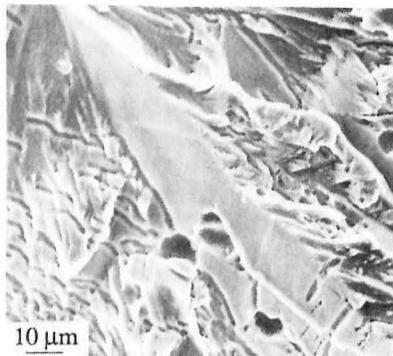
Figure 6. Stepped transgranular fracture in a T651 specimen continuously immersed at an impressed cathodic potential after pre-exposure by alternate immersion.

The results of the SCC corrosion tests under continuous immersion with or without an impressed cathodic potential are presented in table I. The only specimens that show failures are those that were tested at an impressed cathodic potential after pre-exposure, i.e. in conditions favouring hydrogen embrittlement. Examination of the fracture surfaces of these specimens reveals in a

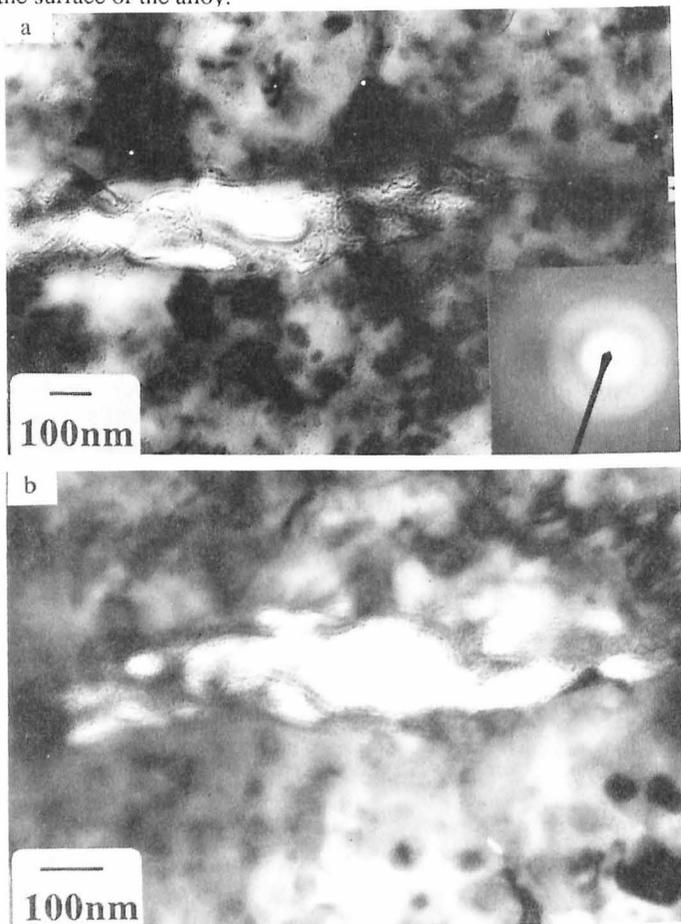
Figure 7 - Bright field TEM micrographs showing the typical microstructure of a peak aged ST specimen around corroded grain boundary crack tips formed after 10 days alternate immersion at 75 MPa. The inset diffraction pattern in a) was taken from the amorphous corrosion product formed nearer the surface of the alloy.

The tips of stress corrosion cracks that propagated in T651 and T7451 ST specimens after 10 days alternate immersion testing at 75 MPa and 310 MPa respectively were examined in cross-section in the TEM. Corresponding observations are presented in figures 7 and 8.

The tips of the stress corrosion cracks observed in the T651 specimen are very fine and localised at or within a few nanometres of grain boundaries (see the characteristic bright field images in figures 7a and 7b, the grain boundary is arrowed in figure 7a). Corrosion was found not to have taken place uniformly along the grain boundaries (see figure 7b) but this could simply reflect the

three-dimensional nature of the crack propagation. The amorphous corrosion product (see inset to figure 7a) visible immediately behind the crack tip corresponds to the consumption of only 100-200 nm of material around the original grain boundary. XEDS analysis indicates that the corroded grain boundary region contains oxygen and chlorine and is enriched in copper with respect to the matrix but is depleted in zinc. The compositional changes for the copper and zinc seem greater than those typically seen at grain boundaries in the peak aged condition where magnesium depletion, rather than the enrichment found in the corroded zone here, is also observed (e.g. [4]). The apparently overaged state of the matrix (note the size of the inter- and intra-granular precipitates) at distances up to about 500 nm from the corroded surface was not typical of the microstructure that was observed in separate TEM foils obtained from positions some millimetres away from the propagating cracks described here.

In the T651 specimens, stress corrosion crack propagation takes place at or within a few nanometres of grain boundaries (see figure 7). The crack progresses in the L-LT plane, regardless of the macroscopic stress orientation, and involves the consumption of about 100 nm of the alloy on either side of the grain boundary in the vicinity of the crack tip (see figure 7). Sub-grain boundaries, even when more favourably oriented with respect to the macroscopic stress state than higher angle boundaries in the L-LT plane, are not preferential sites for crack propagation (see figure 3). We observed no evidence of slip bands or other microstructural features indicative of gross hydrogen embrittlement ahead of the crack tip. These observations are consistent with a process that is controlled by the microstructure in the vicinity of the grain boundary, and thus with studies that demonstrate a correlation between grain boundary microstructure and susceptibility to SCC in copper rich 7xxx alloys. On the basis of the microstructural characterisations of crack paths and crack tips in the T651 specimens, stress accelerated anodic dissolution seems the more plausible propagation mechanism. The observed failure under an impressed cathodic potential, and localised regions of the fracture surface characteristic of transgranular propagation (see table I), would however indicate a dominant susceptibility to hydrogen embrittlement for the T651 temper under continuous immersion. Nevertheless, this failure occurred only after a pre-exposure to an alternate immersion stress corrosion cracking test, and thus in all probability in the presence of a pre-existing stress corrosion crack. For the T651 temper, we thus propose a mixed mechanism of stress corrosion

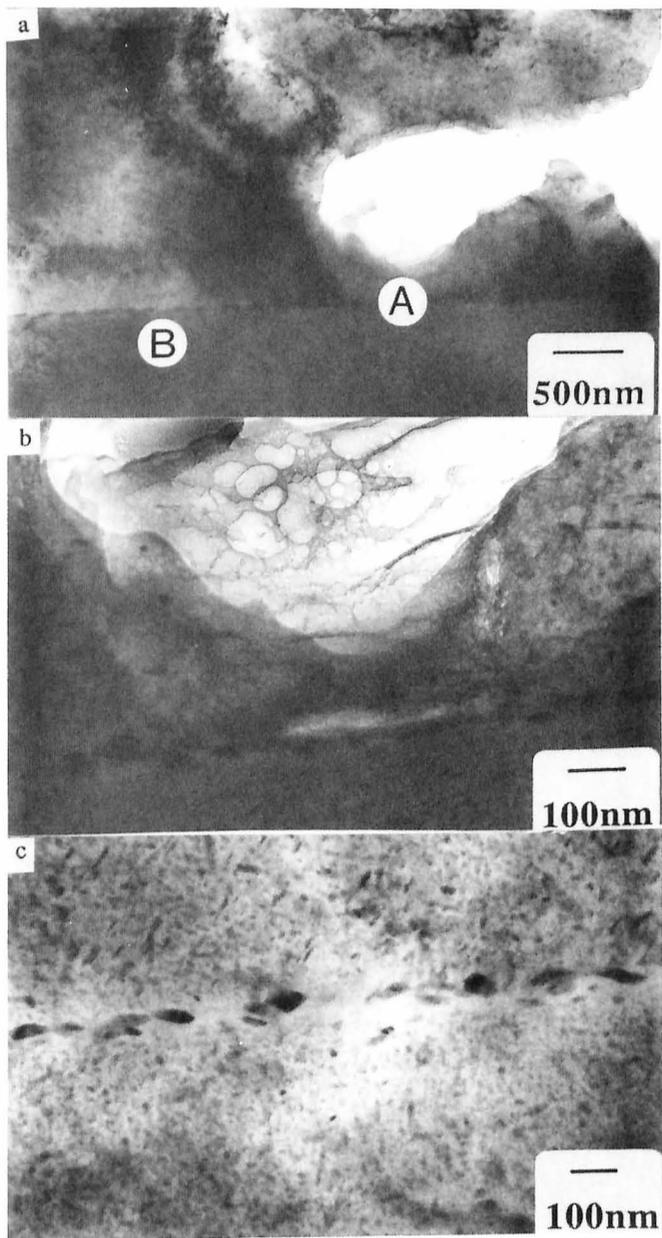
Figure 8 - Bright field TEM micrographs of a corrosion front formed after 10 days alternate immersion at 310 MPa in an overaged specimen showing a) a low magnification view of the whole region and higher magnification micrographs enlarged from b) region A and c) region B in figure 8a.

An overall bright field view of the corroded region which was characterised in the T7451 specimen is presented in figure 8a; higher magnification images for different areas of the grain boundary within it are shown in figures 8b and 8c. In this case the stress corrosion crack is considerably less localised around the grain boundary, seeming if anything to be situated preferentially about 1 μm from it. This observation is confirmed in the bright field micrograph shown in figure 8b, enlarged from the region marked A in figure 8a; one part of the corrosion front abuts the grain boundary but is not propagating preferentially along it. The grain boundary and matrix microstructures at B (see figure 8c), about 2 μm away from the corrosion front, show no morphological features that are substantially different from typical overaged 7150 microstructure. Analysis showed that the Zn:Cu ratio in the surface regions of the alloy examined here is lower than that generally found in the uncorroded state. Moreover, the apparently uncorroded grain boundaries, as shown in figure 8c, are enriched in zinc, which would not normally be expected (e.g. [4]-[6]). The amorphous corrosion product in the fully corroded regions is more straightforward, containing aluminium and oxygen but also minor concentrations of chlorine.
