MICROSTRUCTURE CHANGES OF PARTIAL RE-MELTING REINFORCED A319 ALLOY FOR DIESEL CYLINDER HEADS

M. Kitamura*, W-S. Liu*, S. Tohriyama*, T. Sato** and A. Kamio**

ABSTRACT

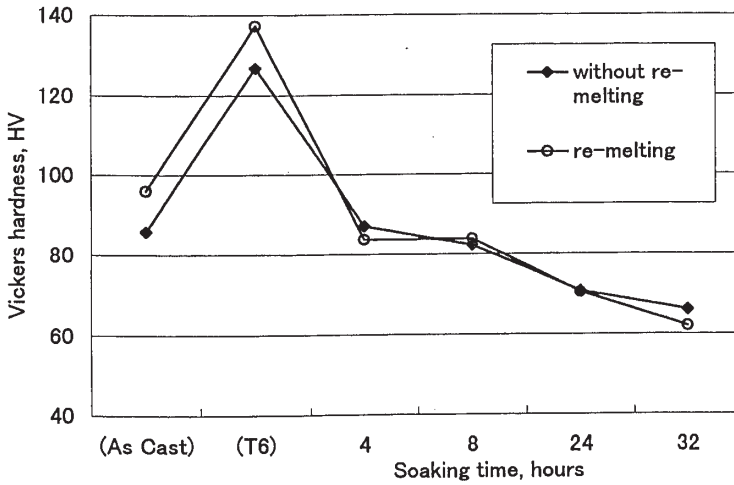
Fig.4 Hardness vs. soaking time curves

The hardness change with respect to soaking time is shown in Fig.4. After soaking for 24~32 hours at 523K, the hardness fell to a final value near 60HV. Another soaking trial of 32 hours at 548K gave the same value. We must note that the hardness value of combustion chamber face was 56~65HV after engine durability test.
